Emergency pipeline on a pontoon bridge

Emergency bypass on a pontoon bridge

A high-speed emergency task for Czajka treatment plant

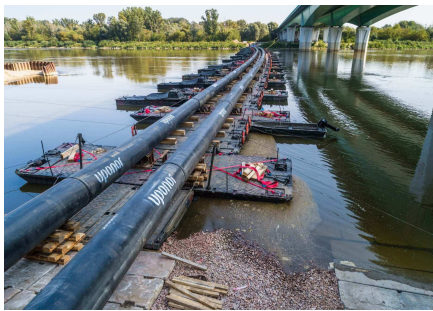
Emergency pipeline on a pontoon bridge

This time, the total length of two DN1,000mm emergency lines was 3,200 metres. Extending the pipeline by 900 metres in total made it possible to connect it directly to the Farysa treatment facility, enabling the pipeline to operate even if water levels increased on the Vistula River. The project used the same pipes as in 2019 with additional sections delivered as a matter of priority from Uponor's factory in Kleszczów. Before work began, Uponor conducted comprehensive lab tests – checking the pipes for surface scratches – as well as weld rupture strength tests. All pipes were found to be fully suited for reuse. As before, thanks to the determination and dedication of Uponor's personnel and service crews, the pipeline was fully operational within 13 days of the commission. Due to the excellent properties of the PE-HD technology, as well as failsafe installation by means of butt welding, the pipeline had the potential to operate for years. It functioned without issues and was only disassembled again when the pontoon bridge had to be removed due to risk of damage from ice sheets forming on the river in October 2020.
