## Renovation of damaged stoneware collector – cracking/short relining

## Renovation of damaged stoneware collector – cracking/short relining with the use of VipLiner modules

Location	Fertigstellung
Tomaszów Mazowiecki, Poland	2014
Gebäudetyp	Product systems
Kommunales	Renovierung, Kanalisation
Art des Projekts	
Renovation

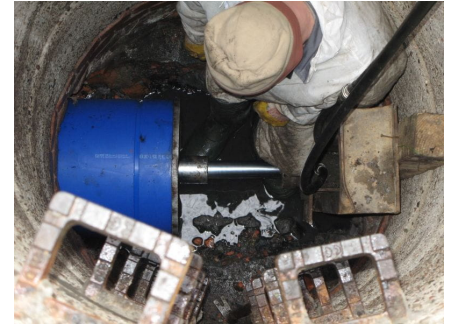
## Renovation of damaged stoneware collector – cracking/short relining with the use of VipLiner modules

In Tomaszów Mazowiecki renovation of a damaged stoneware collector was carried out by means of static cracking method using VipLiner polyethylene modules. In 2013 a decision was made to carry out renovation of the stoneware collector of diameter dn250mm and dn400mm. The collector was leaking in numerous places, particularly in the places of its connection with the manholes.

Upon analysing various renovation technologies it was resolved to repair the collector with the use of VipLiner polyethylene modules PE100 RC with increased resistance to propagation of cracks, point pressure and result of scratching, Blejkan, the contractor of the project, applied the static cracking method, which concerned the crushing of the old collector with the use of the head connected by steel bolted poles with the hydraulic drive hoist and parallel insertion of VipLiner modules after the head. This method allowed to improve the hydraulic parameters of the sewage network. Uponor Infra delivered for this investment VipLiner modules of 0.5 m length and diameter respectively higher than the renovated section (dn355 and 450mm).

The works were carried out in winter at the turn of 2013/2014. The renovation included 8 sections and the longest section between the manholes was 60 m. The contractor commended the easy and simple nature of installation of the modules and the speed of works using VipLiner modules (the average renovation time of a section was approx. 3 days).
