Renovation of damaged stoneware collector – cracking/short relining

Renovation of damaged stoneware collector – cracking/short relining with the use of VipLiner modules

Location	Completion
Tomaszów Mazowiecki, Poland	2014
Building Type	Product systems
Municipal	Renovation, Sewer Municipal
Project Type	
Renovation

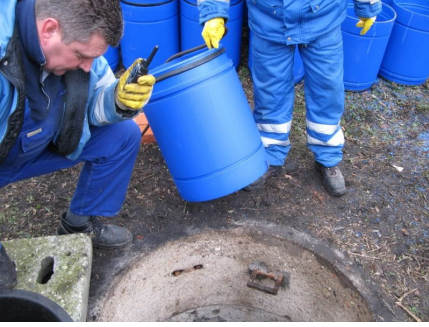
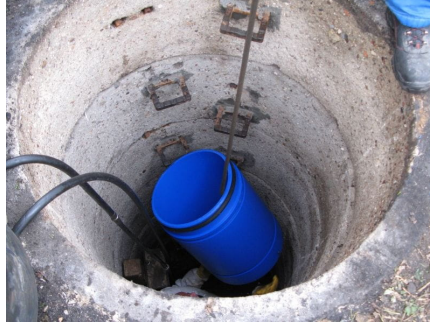
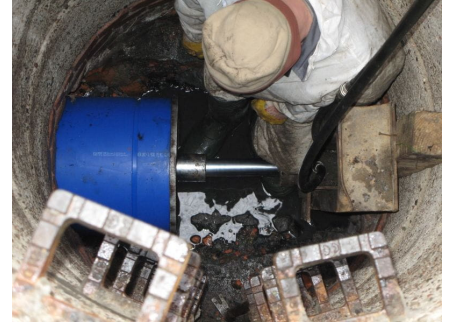
Renovation of damaged stoneware collector – cracking/short relining with the use of VipLiner modules

In Tomaszów Mazowiecki renovation of a damaged stoneware collector was carried out by means of static cracking method using VipLiner polyethylene modules

In Tomaszów Mazowiecki renovation of a damaged stoneware collector was carried out by means of static cracking method using VipLiner polyethylene modules. In 2013 a decision was made to carry out renovation of the stoneware collector of diameter dn250mm and dn400mm. The collector was leaking in numerous places, particularly in the places of its connection with the manholes.

Upon analysing various renovation technologies it was resolved to repair the collector with the use of VipLiner polyethylene modules PE100 RC with increased resistance to propagation of cracks, point pressure and result of scratching, Blejkan, the contractor of the project, applied the static cracking method, which concerned the crushing of the old collector with the use of the head connected by steel bolted poles with the hydraulic drive hoist and parallel insertion of VipLiner modules after the head. This method allowed to improve the hydraulic parameters of the sewage network. Uponor Infra delivered for this investment VipLiner modules of 0.5 m length and diameter respectively higher than the renovated section (dn355 and 450mm).

The works were carried out in winter at the turn of 2013/2014. The renovation included 8 sections and the longest section between the manholes was 60 m. The contractor commended the easy and simple nature of installation of the modules and the speed of works using VipLiner modules (the average renovation time of a section was approx. 3 days).
