## Renovation of damaged stoneware collector – cracking/short relining

## Renovation of damaged stoneware collector – cracking/short relining with the use of VipLiner modules

In Tomaszów Mazowiecki renovation of a damaged stoneware collector was carried out by means of static cracking method using VipLiner polyethylene modules

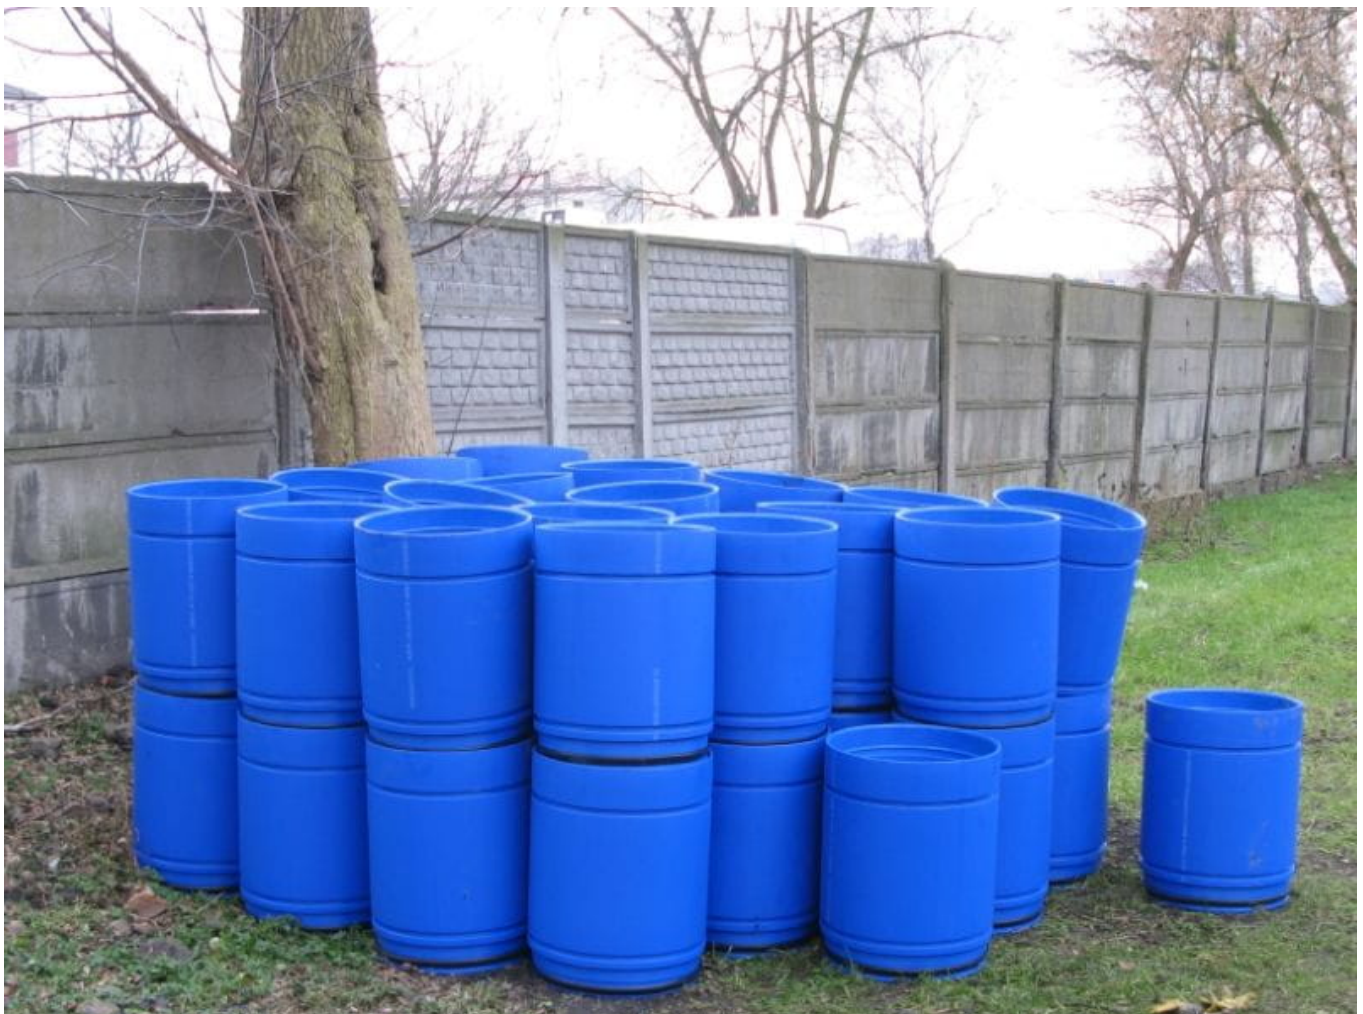
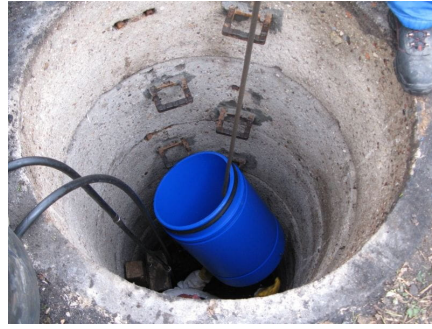
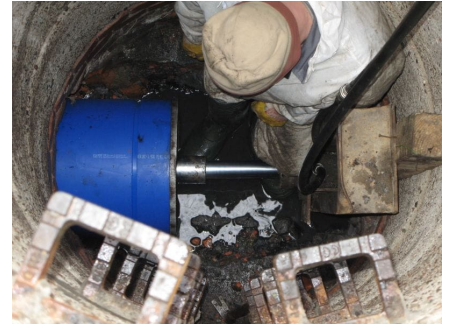
### Renovation of damaged stoneware collector – cracking/short relining with the use of VipLiner modules

In Tomaszów Mazowiecki renovation of a damaged stoneware collector was carried out by means of static cracking method using VipLiner polyethylene modules. In 2013 a decision was made to carry out renovation of the stoneware collector of diameter dn250mm and dn400mm. The collector was leaking in numerous places, particularly in the places of its connection with the manholes.

Upon analysing various renovation technologies it was resolved to repair the collector with the use of VipLiner polyethylene modules PE100 RC with increased resistance to propagation of cracks, point pressure and result of scratching, Blejkan, the contractor of the project, applied the static cracking method, which concerned the crushing of the old collector with the use of the head connected by steel bolted poles with the hydraulic drive hoist and parallel insertion of VipLiner modules after the head. This method allowed to improve the hydraulic parameters of the sewage network. Uponor Infra delivered for this investment VipLiner modules of 0.5 m length and diameter respectively higher than the renovated section (dn355 and 450mm).

The works were carried out in winter at the turn of 2013/2014. The renovation included 8 sections and the longest section between the manholes was 60 m. The contractor commended the easy and simple nature of installation of the modules and the speed of works using VipLiner modules (the average renovation time of a section was approx. 3 days).
