Emergency pipeline on a pontoon bridge

Emergency bypass on a pontoon bridge

A high-speed emergency task for Czajka treatment plant

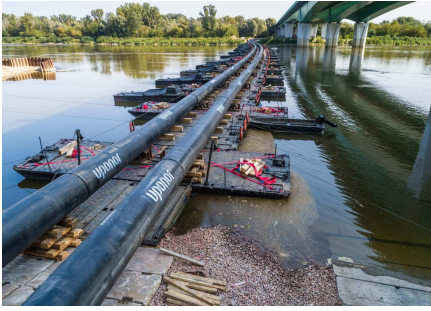
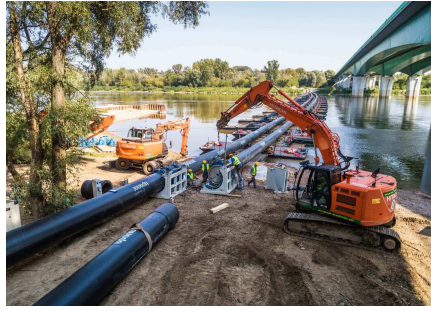
Emergency pipeline on a pontoon bridge

This time, the total length of two DN1,000mm emergency lines was 3,200 metres. Extending the pipeline by 900 metres in total made it possible to connect it directly to the Farysa treatment facility, enabling the pipeline to operate even if water levels increased on the Vistula River. The project used the same pipes as in 2019 with additional sections delivered as a matter of priority from Uponor's factory in Kleszczów. Before work began, Uponor conducted comprehensive lab tests – checking the pipes for surface scratches – as well as weld rupture strength tests. All pipes were found to be fully suited for reuse. As before, thanks to the determination and dedication of Uponor's personnel and service crews, the pipeline was fully operational within 13 days of the commission. Due to the excellent properties of the PE-HD technology, as well as failsafe installation by means of butt welding, the pipeline had the potential to operate for years. It functioned without issues and was only disassembled again when the pontoon bridge had to be removed due to risk of damage from ice sheets forming on the river in October 2020.
