Emergency pipeline on a pontoon bridge

Emergency bypass on a pontoon bridge

A high-speed emergency task for Czajka treatment plant

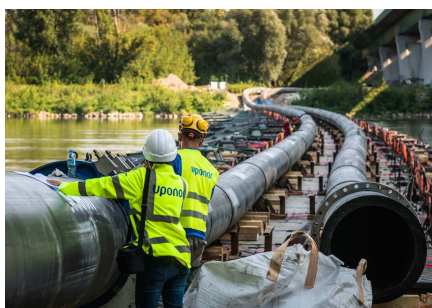
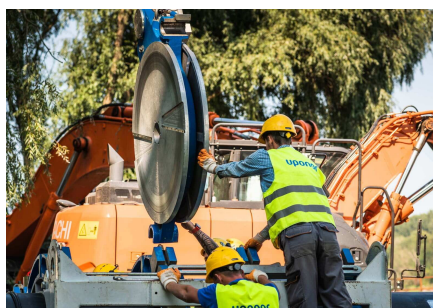
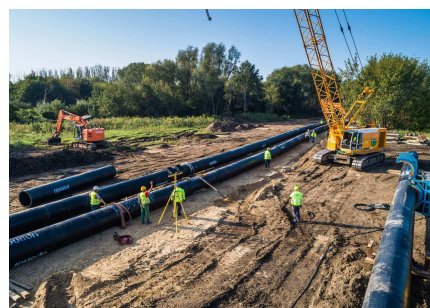
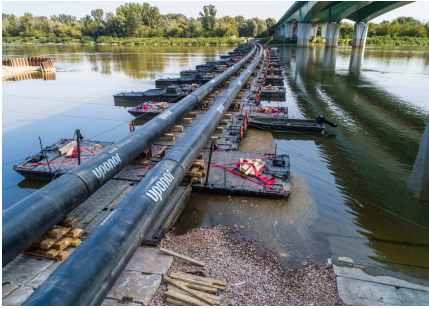
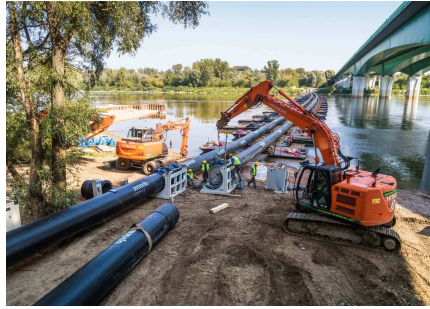
Emergency pipeline on a pontoon bridge

This time, the total length of two DN1,000mm emergency lines was 3,200 metres. Extending the pipeline by 900 metres in total made it possible to connect it directly to the Farysa treatment facility, enabling the pipeline to operate even if water levels increased on the Vistula River. The project used the same pipes as in 2019 with additional sections delivered as a matter of priority from Uponor's factory in Kleszczów. Before work began, Uponor conducted comprehensive lab tests – checking the pipes for surface scratches – as well as weld rupture strength tests. All pipes were found to be fully suited for reuse. As before, thanks to the determination and dedication of Uponor's personnel and service crews, the pipeline was fully operational within 13 days of the commission. Due to the excellent properties of the PE-HD technology, as well as failsafe installation by means of butt welding, the pipeline had the potential to operate for years. It functioned without issues and was only disassembled again when the pontoon bridge had to be removed due to risk of damage from ice sheets forming on the river in October 2020.

Usually, projects like these take months to complete but in this case speed was of the essence. In an amazing feat, Uponor Infra was able to deliver and join the pipes required for the emergency pipeline in only eight days. The total length of the two lines of the DN1,000mm pipes was 2,200 metres, with two 250-metre sections resting on a pontoon bridge built by the Polish Army. To meet this unique challenge, Uponor mobilised all its resources: the production schedule at the company's factory in Kleszczów was adjusted to meet the urgent demand for pipes, with around-the-clock deliveries to the installation site, six service teams were delegated to the project and extra welding machines were brought in from other building sites from all over Poland. Thanks to the expertise, experience and tireless work of the Uponor crew, the new pipeline took over the functionality of the damaged collector after just 12 days, stopping the discharge of sewage into the Vistula River.
