Renovation of damaged stoneware collector – cracking/short relining

In Tomaszów Mazowiecki renovation of a damaged stoneware collector was carried out by means of static cracking method using VipLiner polyethylene modules

Location	Zaključek
Tomaszów Mazowiecki, Poland	2014
Vrsta objekta	Product systems
Javni objekti	Renovation, Sewer Municipal
Vrsta projekta	
Renovation

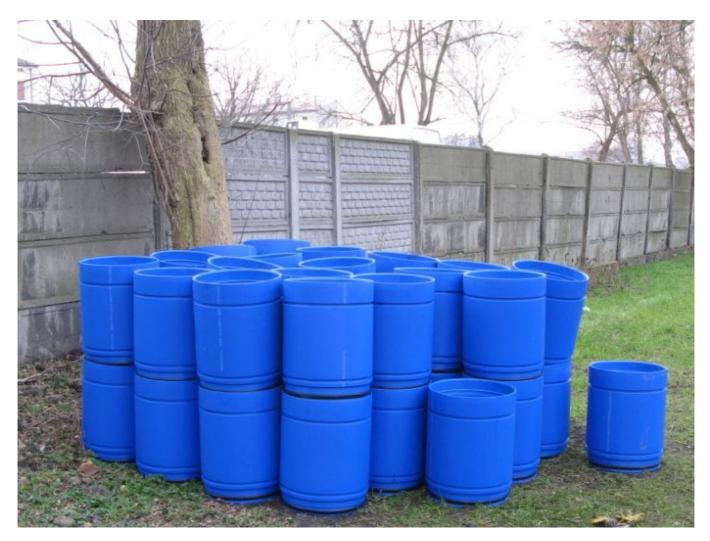
#### Renovation of damaged stoneware collector - cracking/short relining with the use of VipLiner modules

Upon analysing various renovation technologies it was resolved to repair the collector with the use of VipLiner polyethylene modules PE100 RC with increased resistance to propagation of cracks, point pressure and result of scratching, Blejkan, the contractor of the project, applied the static cracking method, which concerned the crushing of the old collector with the use of the head connected by steel bolted poles with the hydraulic drive hoist and parallel insertion of VipLiner modules after the head. This method allowed to improve the hydraulic parameters of the sewage network. Uponor Infra delivered for this investment VipLiner modules of 0.5 m length and diameter respectively higher than the renovated section (dn355 and 450mm).

The works were carried out in winter at the turn of 2013/2014. The renovation included 8 sections and the longest section between the manholes was 60 m. The contractor commended the easy and simple nature of installation of the modules and the speed of works using VipLiner modules (the average renovation time of a section was approx. 3 days).
