## Emergency pipeline on a pontoon bridge

## Emergency bypass on a pontoon bridge

## A high-speed emergency task for Czajka treatment plant

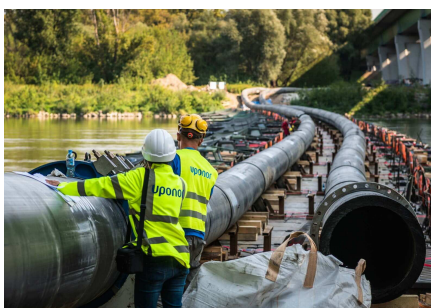
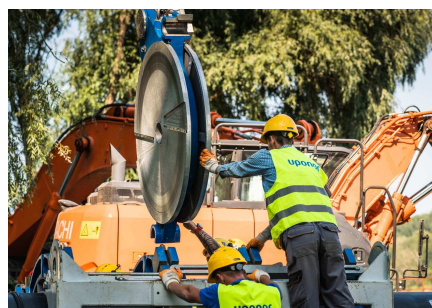
### Emergency pipeline on a pontoon bridge

This time, the total length of two DN1,000mm emergency lines was 3,200 metres. Extending the pipeline by 900 metres in total made it possible to connect it directly to the Farysa treatment facility, enabling the pipeline to operate even if water levels increased on the Vistula River. The project used the same pipes as in 2019 with additional sections delivered as a matter of priority from Uponor's factory in Kleszczów. Before work began, Uponor conducted comprehensive lab tests – checking the pipes for surface scratches – as well as weld rupture strength tests. All pipes were found to be fully suited for reuse. As before, thanks to the determination and dedication of Uponor's personnel and service crews, the pipeline was fully operational within 13 days of the commission. Due to the excellent properties of the PE-HD technology, as well as failsafe installation by means of butt welding, the pipeline had the potential to operate for years. It functioned without issues and was only disassembled again when the pontoon bridge had to be removed due to risk of damage from ice sheets forming on the river in October 2020.
