Renovation of damaged stoneware collector – cracking/short relining

Renovation of damaged stoneware collector – cracking/short relining with the use of VipLiner modules

Tomaszów Mazowiecki, Poland 2014

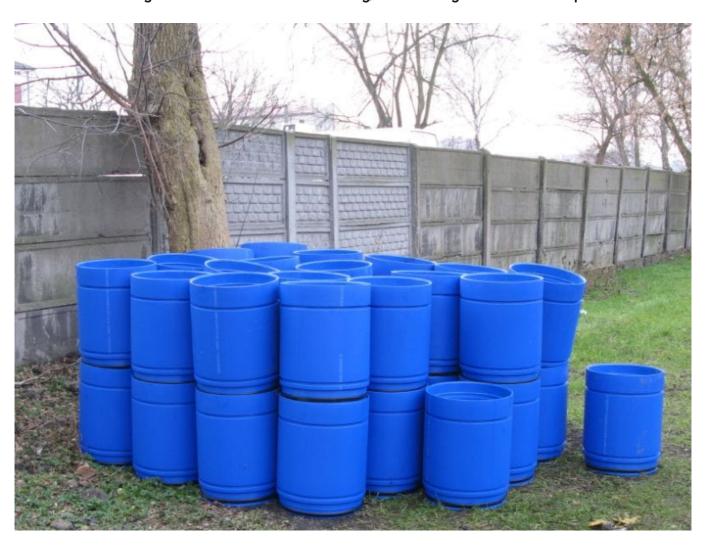
Renovation of damaged stoneware collector - cracking/short relining with the use of VipLiner modules

Upon analysing various renovation technologies it was resolved to repair the collector with the use of VipLiner polyethylene modules PE100 RC with increased resistance to propagation of cracks, point pressure and result of scratching, Blejkan, the contractor of the project, applied the static cracking method, which concerned the crushing of the old collector with the use of the head connected by steel bolted poles with the hydraulic drive hoist and parallel insertion of VipLiner modules after the head. This method allowed to improve the hydraulic parameters of the sewage network. Uponor Infra delivered for this investment VipLiner modules of 0.5 m length and diameter respectively higher than the renovated section (dn355 and 450mm).

The works were carried out in winter at the turn of 2013/2014. The renovation included 8 sections and the longest section between the manholes was 60 m. The contractor commended the easy and simple nature of installation of the modules and the speed of works using VipLiner modules (the average renovation time of a section was approx. 3 days).
