Renovation of damaged stoneware collector – cracking/short relining

Renovation of damaged stoneware collector – cracking/short relining with the use of VipLiner modules

Location	Completion
Tomaszów Mazowiecki, Poland	2014
Building Type	Product systems
☒☒☒☒	Renovation, Sewer Municipal
Project Type	
Renovation

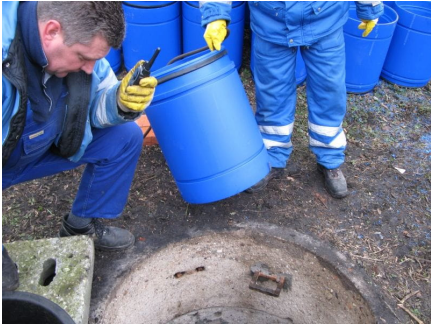
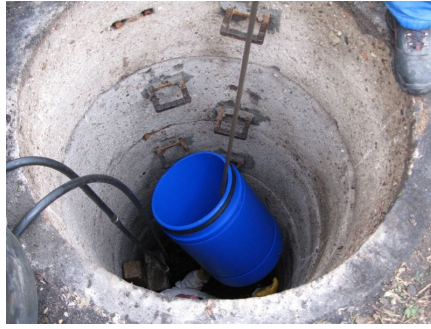
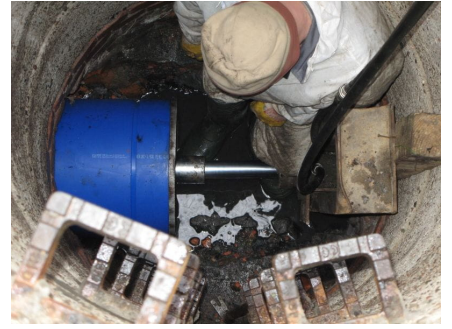
Renovation of damaged stoneware collector – cracking/short relining with the use of VipLiner modules

Upon analysing various renovation technologies it was resolved to repair the collector with the use of VipLiner polyethylene modules PE100 RC with increased resistance to propagation of cracks, point pressure and result of scratching, Blejkan, the contractor of the project, applied the static cracking method, which concerned the crushing of the old collector with the use of the head connected by steel bolted poles with the hydraulic drive hoist and parallel insertion of VipLiner modules after the head. This method allowed to improve the hydraulic parameters of the sewage network. Uponor Infra delivered for this investment VipLiner modules of 0.5 m length and diameter respectively higher than the renovated section (dn355 and 450mm).

The works were carried out in winter at the turn of 2013/2014. The renovation included 8 sections and the longest section between the manholes was 60 m. The contractor commended the easy and simple nature of installation of the modules and the speed of works using VipLiner modules (the average renovation time of a section was approx. 3 days).
