Climate Control Zoning System II Wireless Base Unit, 6 zones technical bulletin

Climate Control Zoning System II Wireless Base Unit firmware upgrade installation instructions

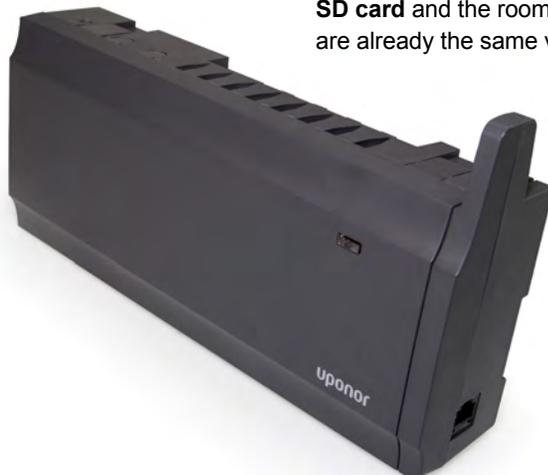
A3801165 Climate Control Zoning System II
Wireless Base Unit, 6 zones (X-165)

1. Remove power from the controller.
The red LED in the upper right hand corner will be dark or unlit.
2. Remove the **Data Save SD** card from the controller. Put this aside and keep for later. **IMPORTANT!** Do not mix up the **Data Save SD** cards between controllers.
