## Renovation of the sewage collector

### Optimal solution for different types of loads

Renovation of a collector pipe by the sea

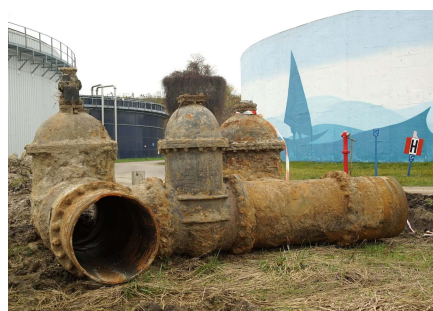
## Renovation of the sewage collector in Swarzewo

The installation technology consists of pulling long sections of PEHD pressure pipe into the old pipe, with the outer diameter of the pipe to be introduced originally being equal to or slightly larger than the inner diameter of the pipe to be repaired. Then, after welding, the pipe is pulled through the reducer so that the outside diameter is reduced and it can be inserted into the pipeline to be repaired. The pulling force is then released and the PEHD pipe, after a relaxation process, presses tightly against the inner wall of the old pipeline. The advantage of this technology is that a small reduction in the inside diameter of the repaired duct is achieved, which, with a significant reduction in surface roughness, significantly improves throughput. There is also no need to fill in the space between the old and new pipe, the renewed pipe does not require further repairs and maintenance. An additional benefit is the structural reinforcement of the repaired sewer - the new pipeline is self-supporting, carrying the load.

Deliveries of pipes for the described investment started in September 2021. For the renovation of the Władysławowo-Swarzewo collector pipe, it was decided to use WehoPipe PE100 DN600x23.0 PN6.3 SDR26 pressure pipes with a total length of 2,530 m. They were transported to the worksite in 12.5 m sections. The pipes were joined together by butt welding. A DN630 welding machine was used for this purpose. Deliveries were completed in February 2022.
