Water treatment plant

Aeration tank to improve the water quality

Water company Ylä-Savon Vesi Oy needed a solution to improve the water quality in water supply process. The solution was an aeration tank made of Weholite.

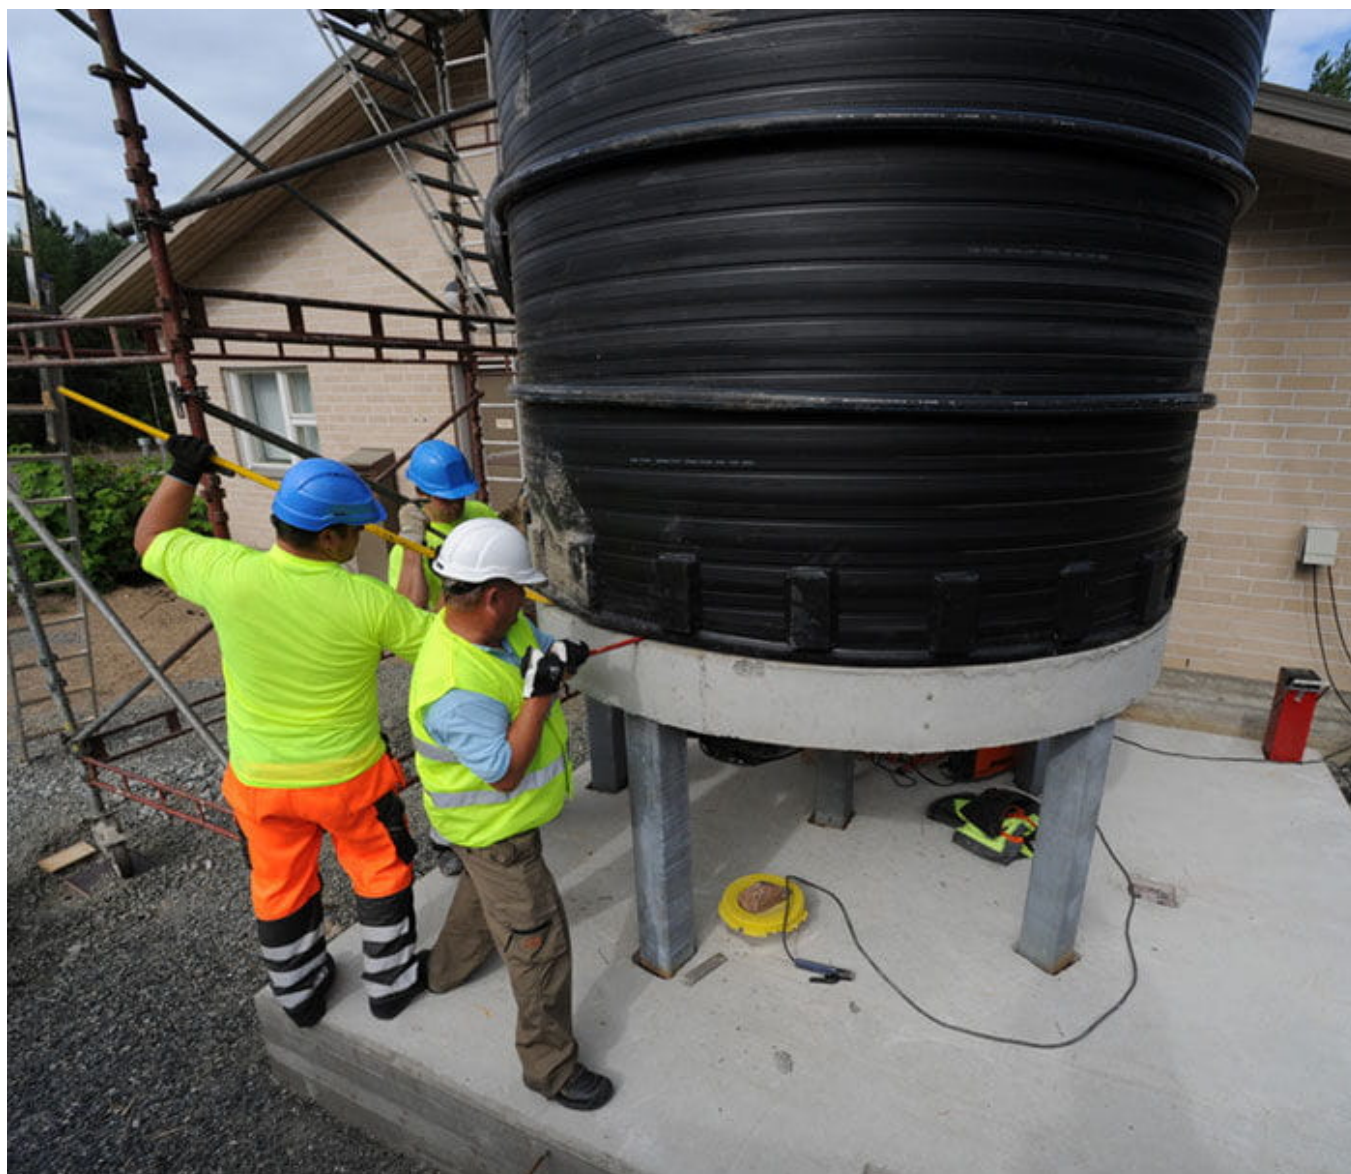
Weholite aeration tank

In aeration that improves water quality, water is led to the tower from above. The water flows through the infill mattress in the tower, removing the carbon dioxide in the raw water. Aeration can be adjusted by blowing clean air under the tower through the mattress upstream.

- The concrete slab under the tower had already been made in advance. On top of the base slab, we installed feet just over a meter high, on which we lifted a round concrete slab. The tower was attached to it, says work manager Kalevi Savolainen.

Valves and piping were installed in the space under the tower. The insulation of the lower part was also supplemented. The finished tower was raised with a truck crane. - The work went as planned. Already during the installation work, guests visited the site. The insulated aeration tank is interesting because there is little space for such massive structures in a few places, Savolainen says. The contractor completed the tower by installing exterior cladding.
