Renovation of damaged stoneware collector – cracking/short relining

Renovation of damaged stoneware collector – cracking/short relining with the use of VipLiner modules

Location	Dokončení
Tomaszów Mazowiecki, Poland	2014
Typ budovy	Product systems
Veřejné budovy	Rekonstrukce, Obecní kanalizace
Typ projektu	
Renovation

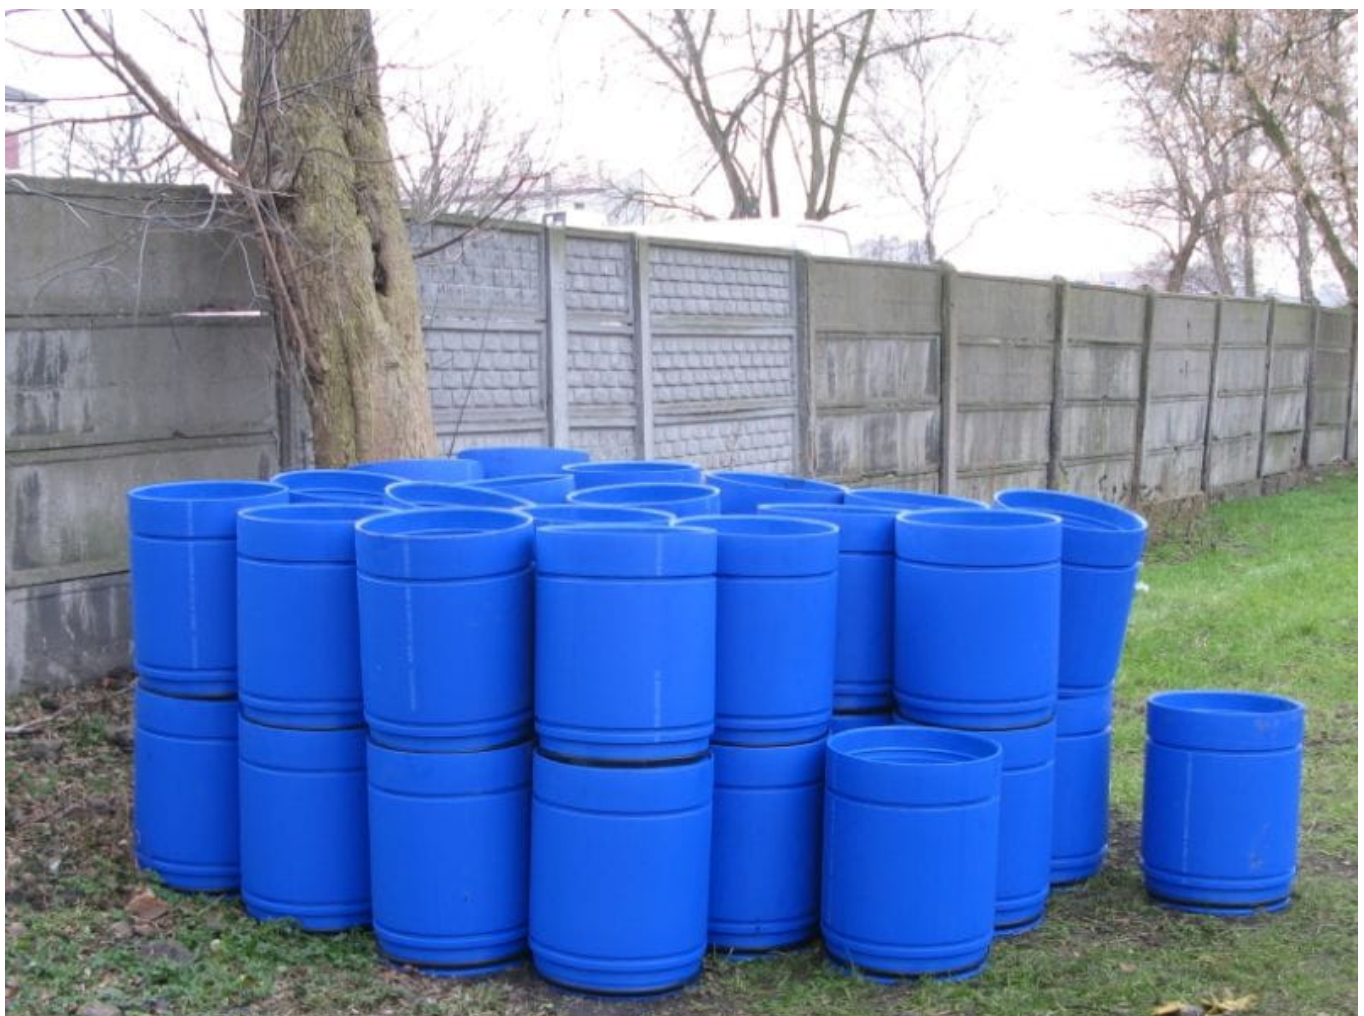
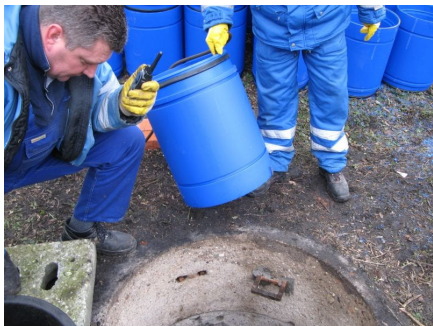
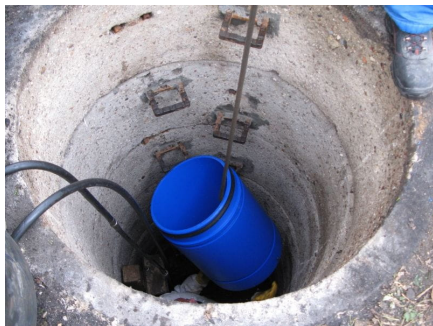
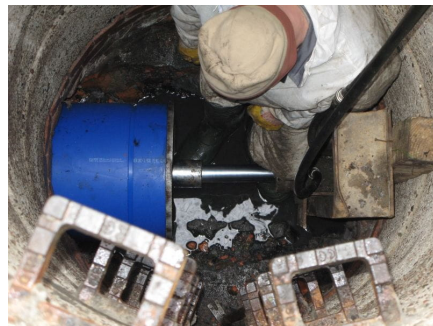
Renovation of damaged stoneware collector – cracking/short relining with the use of VipLiner modules

In Tomaszów Mazowiecki renovation of a damaged stoneware collector was carried out by means of static cracking method using VipLiner polyethylene modules. In 2013 a decision was made to carry out renovation of the stoneware collector of diameter dn250mm and dn400mm. The collector was leaking in numerous places, particularly in the places of its connection with the manholes.

Upon analysing various renovation technologies it was resolved to repair the collector with the use of VipLiner polyethylene modules PE100 RC with increased resistance to propagation of cracks, point pressure and result of scratching, Blejkan, the contractor of the project, applied the static cracking method, which concerned the crushing of the old collector with the use of the head connected by steel bolted poles with the hydraulic drive hoist and parallel insertion of VipLiner modules after the head. This method allowed to improve the hydraulic parameters of the sewage network. Uponor Infra delivered for this investment VipLiner modules of 0.5 m length and diameter respectively higher than the renovated section (dn355 and 450mm).

The works were carried out in winter at the turn of 2013/2014. The renovation included 8 sections and the longest section between the manholes was 60 m. The contractor commended the easy and simple nature of installation of the modules and the speed of works using VipLiner modules (the average renovation time of a section was approx. 3 days).
