## Water treatment plant

2.4 m diameter Weholite tank

### Aeration tank to improve the water quality

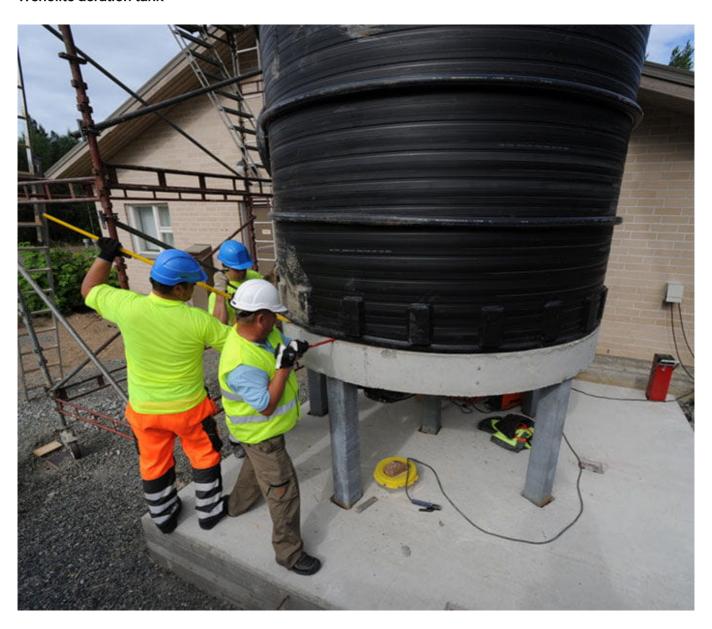
#### Weholite aeration tank

In aeration that improves water quality, water is led to the tower from above. The water flows through the infill mattress in the tower, removing the carbon dioxide in the raw water. Aeration can be adjusted by blowing clean air under the tower through the mattress upstream.

The amount of air does not require the tower to withstand greater pressure than normal in normal use, but the Weholite tank can also withstand the full water pressure of the tank, for example in the event of washing or disturbances.

- The thermal insulation of the tower was done at the factory, and there was no need to work with the villas on the construction site, Heiskanen says. The aeration tower was completed at the Vaasa plant. Savo-Karjalan Vesihuolto Oy installed the aeration tower in the summer of 2010.
- The concrete slab under the tower had already been made in advance. On top of the base slab, we installed feet just over a meter high, on which we lifted a round concrete slab. The tower was attached to it, says work manager Kalevi Savolainen.

Valves and piping were installed in the space under the tower. The insulation of the lower part was also supplemented. The finished tower was raised with a truck crane. - The work went as planned. Already during the installation work, guests visited the site. The insulated aeration tank is interesting because there is little space for such massive structures in a few places, Savolainen says. The contractor completed the tower by installing exterior cladding.
