lisalmen Vesi renovated a trunk line by relining

Fakten zum Projekt

Location	Fertigstellung
lissalmi, Finland	2017
Gebäudetyp	Product systems
Kommunales	Trinkwasser
Art des Projekts	
Renovation

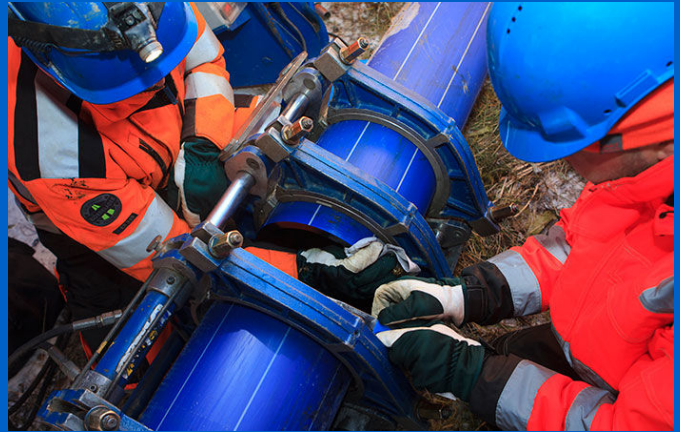
- ✓ 2.1 kilometres of 280-millimetre Profuse pipe
