Quick installation in the Konotopa channel

Weholite guaranteed a simple and quick installation in the Konotopa channel

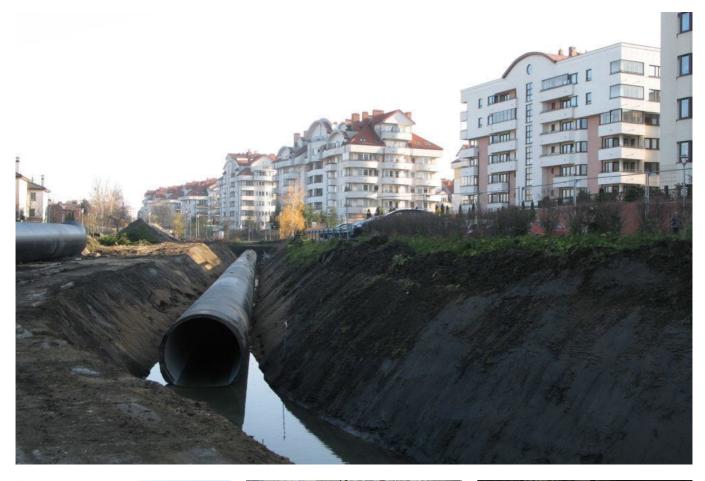
Weholite guaranteed a simple and quick installation in the Konotopa channel

Following a tender, in September 2016 Drainage Construction Company Tolos was appointed as the general contractor for the project. Uponor Infra delivered a total of 165 metres of structured-wall PE-HD Weholite, DN/ID 2,000mm SN4 pipes to the installation site. Prep work included clearing the channel of concrete slab lining, dredging the ditch to make room for the new pipeline and laying the bedding. Uponor Infra pipe service staff then joined up the Weholite pipes to form two sections. The work was carried out on dry land on the right bank of the channel, by means of automatic extrusion welding using a WLI- 3000 machine. This guaranteed the 100% tightness and homogeneity of the pipeline. A 100- metre section of pipeline was then lowered into the ditch, followed by the remaining 50-metre section with a fitted bend two days later. Since the channel was operational during installation, the two connecting sections of the pipeline were raised above the water level, where they were welded together. The pipeline was then connected to a reinforced concrete inlet of the underground section of the channel. A socket- and- spigot DN/ID200mm joint was fitted onto the pipeline, connecting it to an existing stormwater channel. Finally, the ditch was backfilled. At the spot where the new pipeline meets the open section of the channel, an outlet was secured with a steel grate to prevent unauthorised entry. The installation was completed in December 2016.
