Renovation of damaged stoneware collector – cracking/short relining

Renovation of damaged stoneware collector – cracking/short relining with the use of VipLiner modules

Location	Completion
Tomaszów Mazowiecki, Poland	2014
Building Type	Product systems
Municipal	Renovation, Sewer Municipal
Project Type	
Renovation

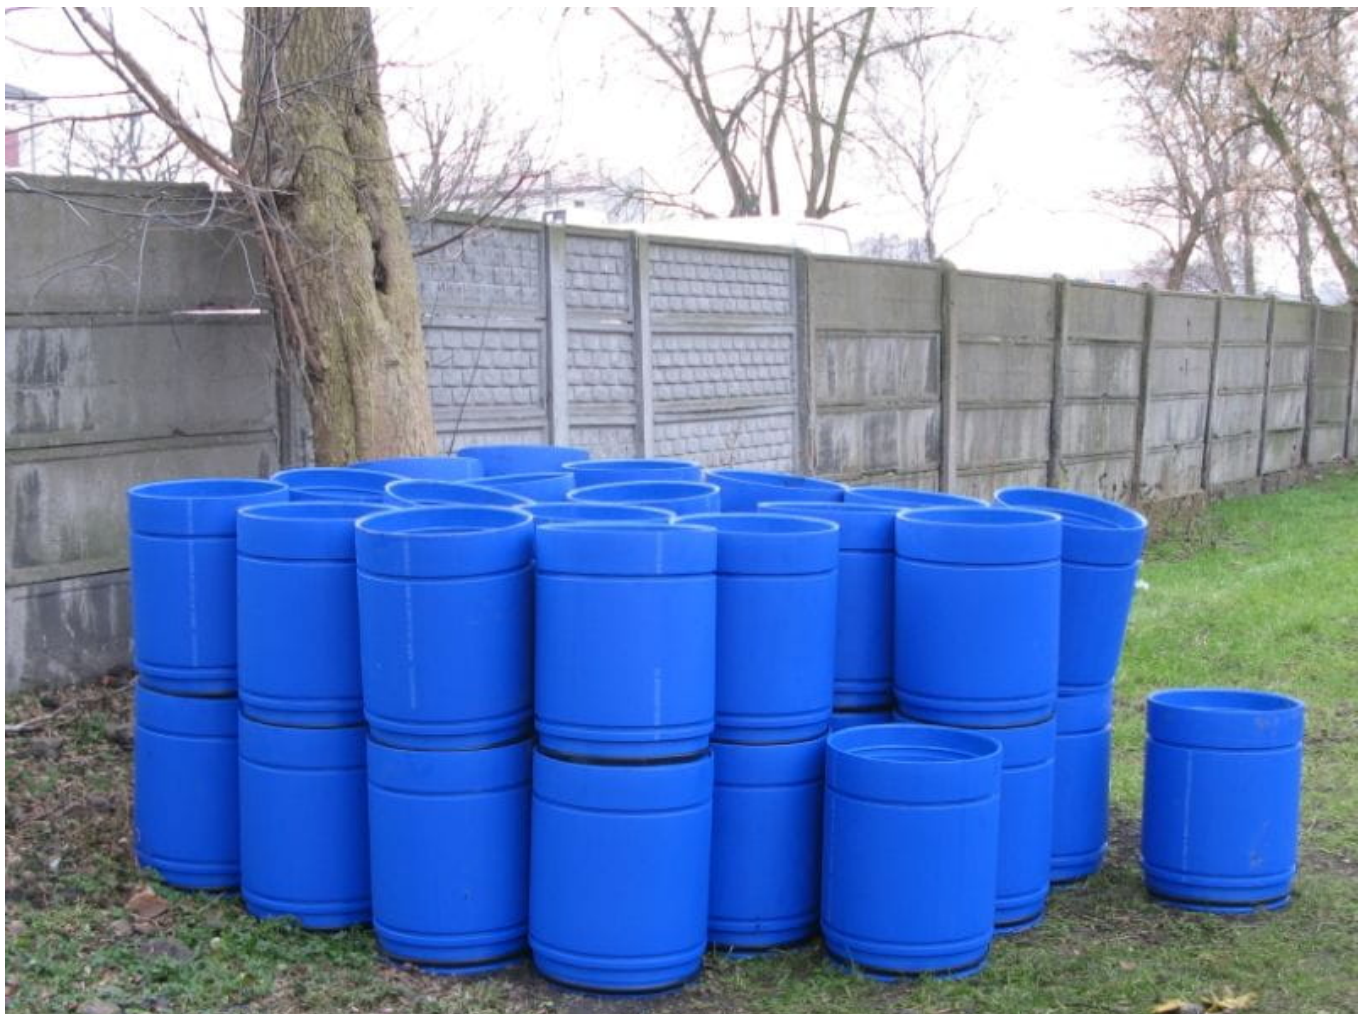
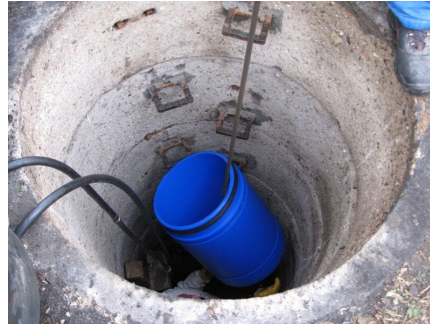
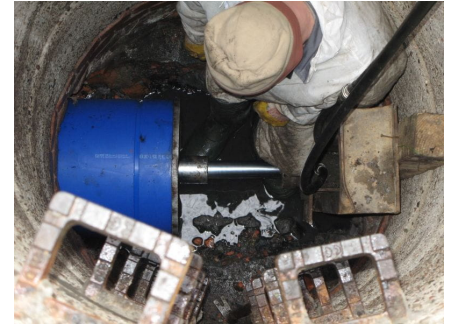
Renovation of damaged stoneware collector – cracking/short relining with the use of VipLiner modules

Upon analysing various renovation technologies it was resolved to repair the collector with the use of VipLiner polyethylene modules PE100 RC with increased resistance to propagation of cracks, point pressure and result of scratching, Blejkan, the contractor of the project, applied the static cracking method, which concerned the crushing of the old collector with the use of the head connected by steel bolted poles with the hydraulic drive hoist and parallel insertion of VipLiner modules after the head. This method allowed to improve the hydraulic parameters of the sewage network. Uponor Infra delivered for this investment VipLiner modules of 0.5 m length and diameter respectively higher than the renovated section (dn355 and 450mm).

The works were carried out in winter at the turn of 2013/2014. The renovation included 8 sections and the longest section between the manholes was 60 m. The contractor commended the easy and simple nature of installation of the modules and the speed of works using VipLiner modules (the average renovation time of a section was approx. 3 days).
