Water treatment plant

2.4 m diameter Weholite tank

Aeration tank to improve the water quality

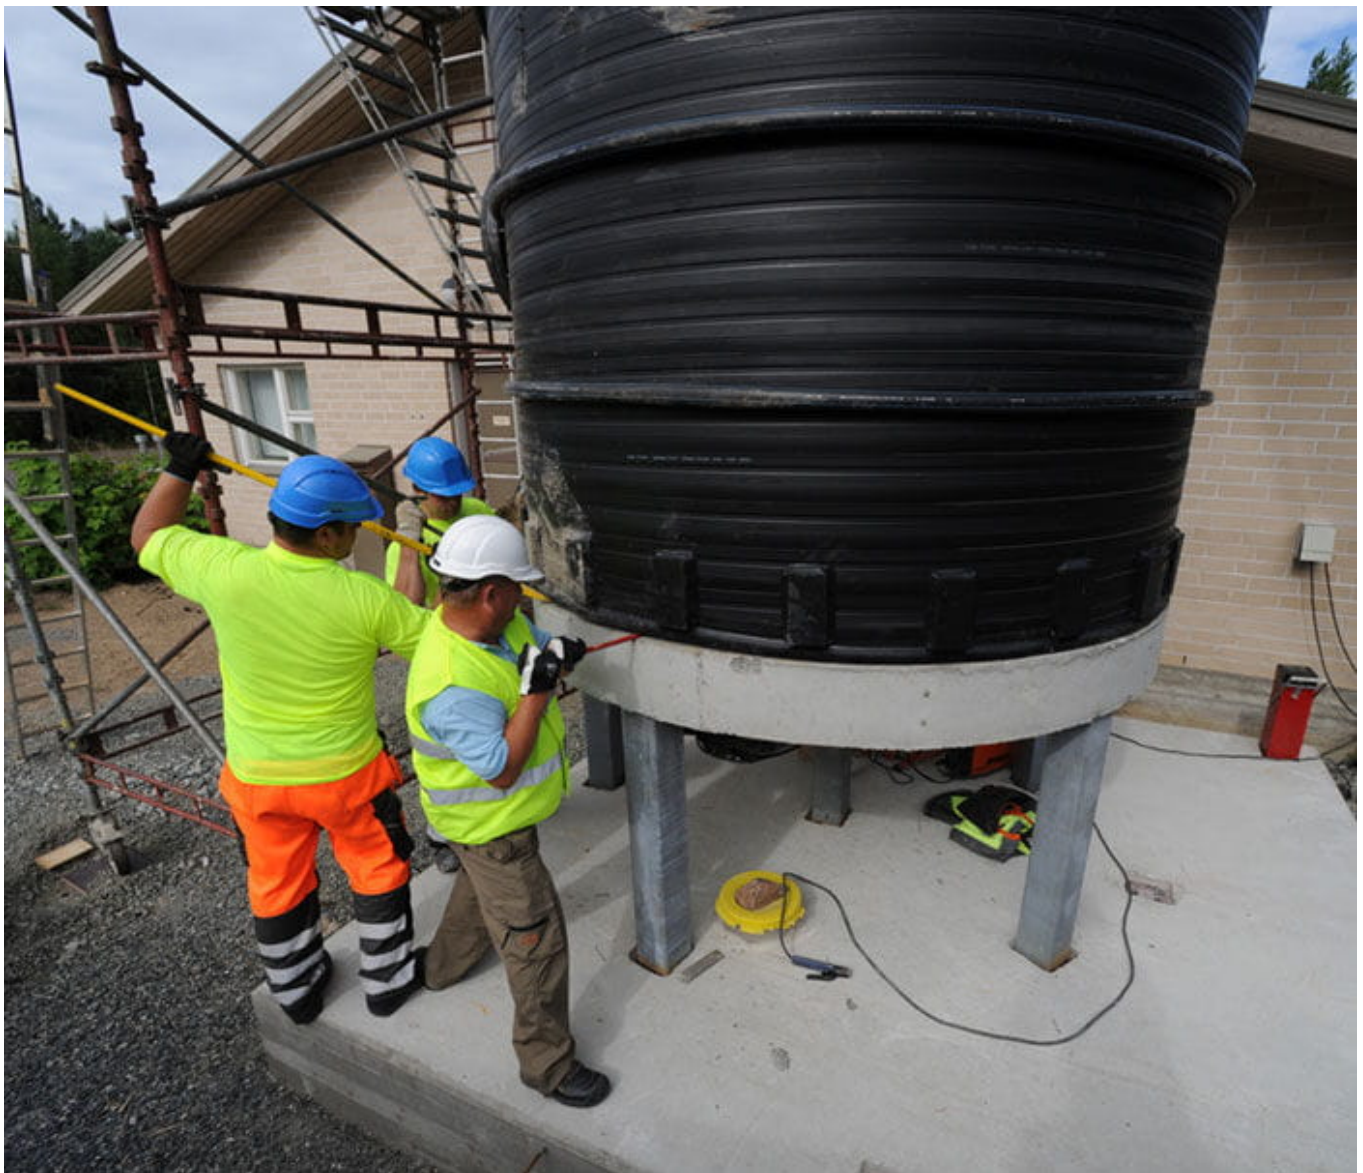
Weholite aeration tank

In aeration that improves water quality, water is led to the tower from above. The water flows through the infill mattress in the tower, removing the carbon dioxide in the raw water. Aeration can be adjusted by blowing clean air under the tower through the mattress upstream.

- The thermal insulation of the tower was done at the factory, and there was no need to work with the villas on the construction site, Heiskanen says. The aeration tower was completed at the Vaasa plant. Savo-Karjalan Vesihuolto Oy installed the aeration tower in the summer of 2010.

- The concrete slab under the tower had already been made in advance. On top of the base slab, we installed feet just over a meter high, on which we lifted a round concrete slab. The tower was attached to it, says work manager Kalevi Savolainen.

Valves and piping were installed in the space under the tower. The insulation of the lower part was also supplemented. The finished tower was raised with a truck crane. - The work went as planned. Already during the installation work, guests visited the site. The insulated aeration tank is interesting because there is little space for such massive structures in a few places, Savolainen says. The contractor completed the tower by installing exterior cladding.
