Renovation of damaged stoneware collector – cracking/short relining

Renovation of damaged stoneware collector – cracking/short relining with the use of VipLiner modules

In Tomaszów Mazowiecki renovation of a damaged stoneware collector was carried out by means of static cracking method using VipLiner polyethylene modules

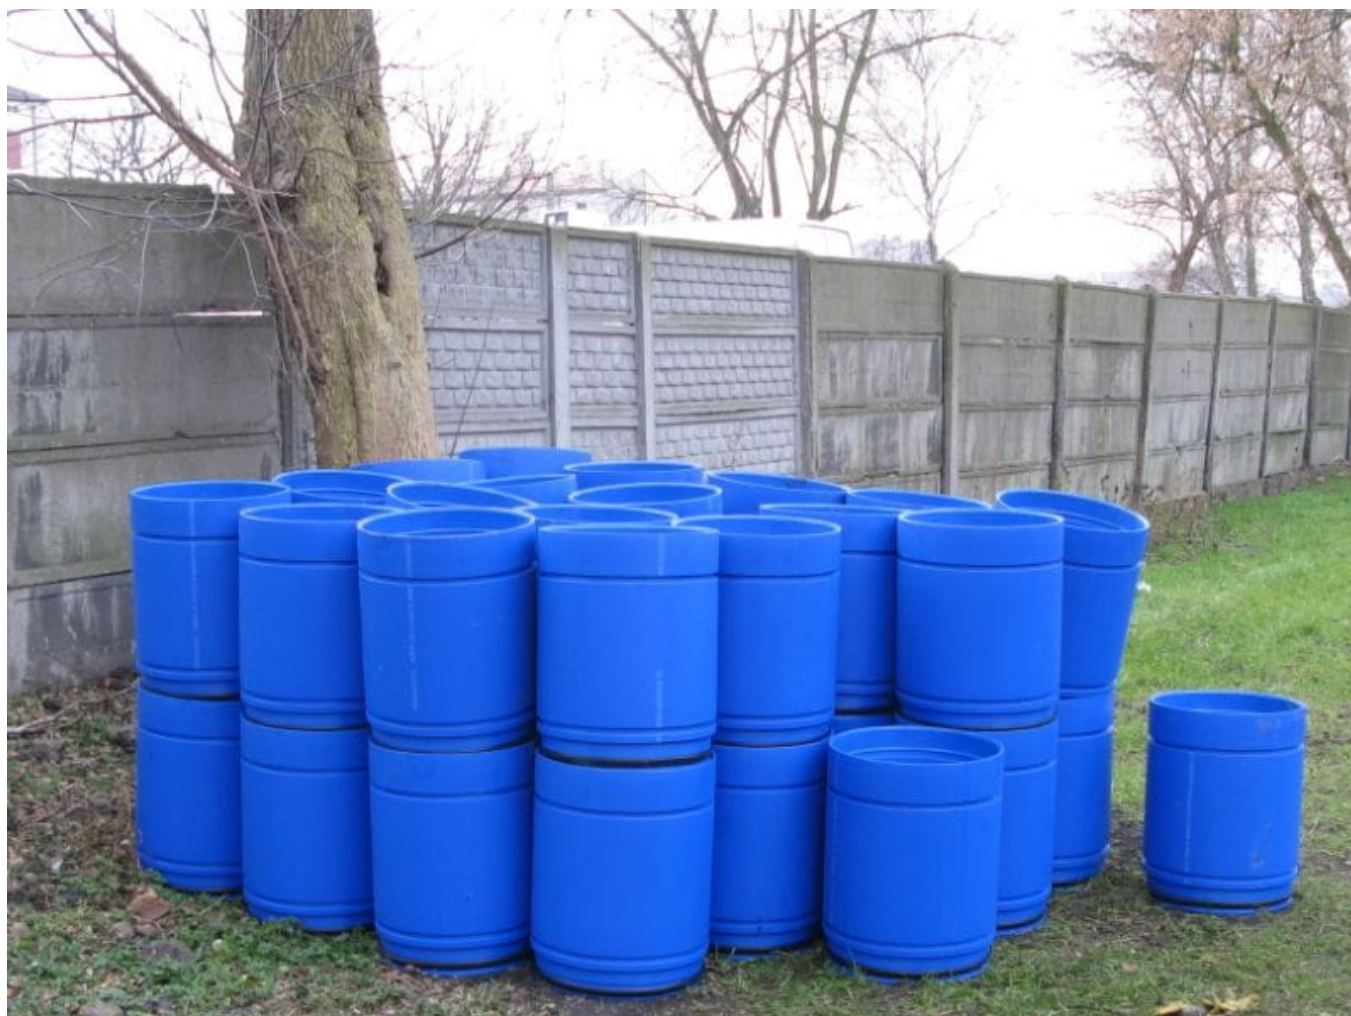
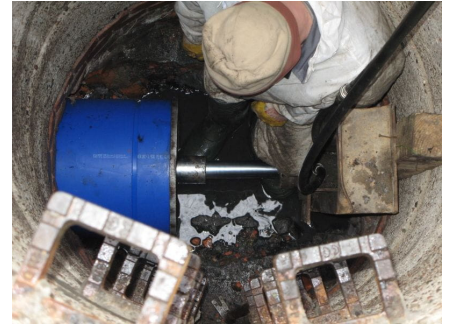
Renovation of damaged stoneware collector – cracking/short relining with the use of VipLiner modules

In Tomaszów Mazowiecki renovation of a damaged stoneware collector was carried out by means of static cracking method using VipLiner polyethylene modules. In 2013 a decision was made to carry out renovation of the stoneware collector of diameter dn250mm and dn400mm. The collector was leaking in numerous places, particularly in the places of its connection with the manholes.

Upon analysing various renovation technologies it was resolved to repair the collector with the use of VipLiner polyethylene modules PE100 RC with increased resistance to propagation of cracks, point pressure and result of scratching, Blejkan, the contractor of the project, applied the static cracking method, which concerned the crushing of the old collector with the use of the head connected by steel bolted poles with the hydraulic drive hoist and parallel insertion of VipLiner modules after the head. This method allowed to improve the hydraulic parameters of the sewage network. Uponor Infra delivered for this investment VipLiner modules of 0.5 m length and diameter respectively higher than the renovated section (dn355 and 450mm).

The works were carried out in winter at the turn of 2013/2014. The renovation included 8 sections and the longest section between the manholes was 60 m. The contractor commended the easy and simple nature of installation of the modules and the speed of works using VipLiner modules (the average renovation time of a section was approx. 3 days).
