Water treatment plant

- ✔ 2.4 m diameter Weholite tank

Aeration tank to improve the water quality

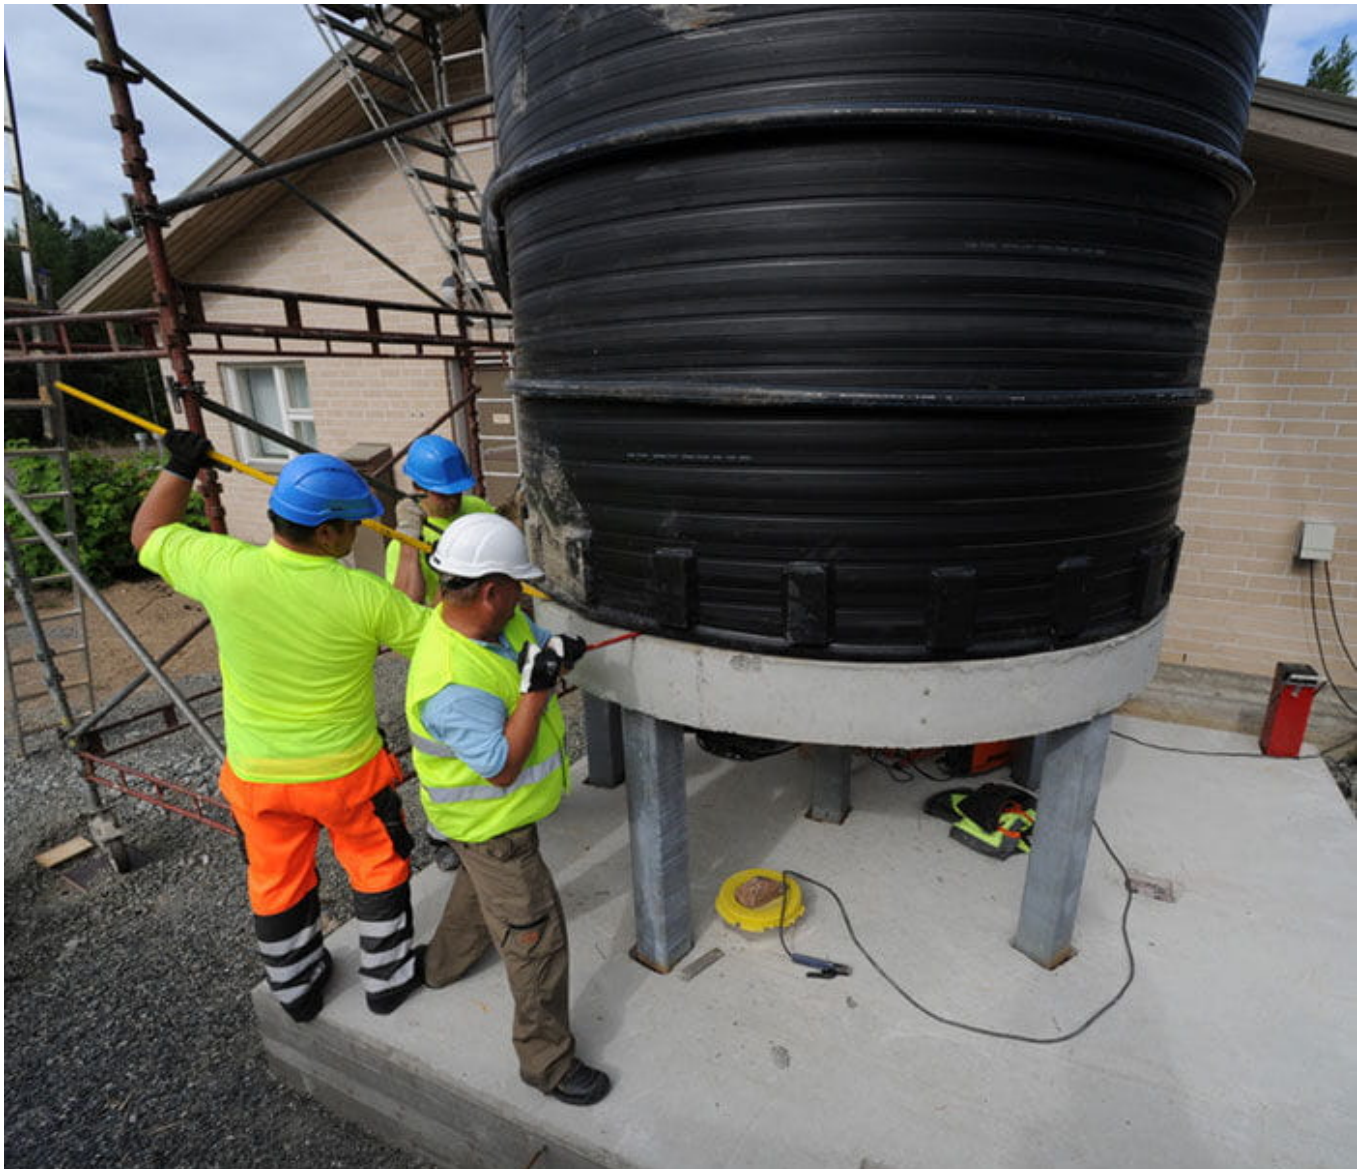
Weholite aeration tank

In aeration that improves water quality, water is led to the tower from above. The water flows through the infill mattress in the tower, removing the carbon dioxide in the raw water. Aeration can be adjusted by blowing clean air under the tower through the mattress upstream.

The amount of air does not require the tower to withstand greater pressure than normal in normal use, but the Weholite tank can also withstand the full water pressure of the tank, for example in the event of washing or disturbances.

- The concrete slab under the tower had already been made in advance. On top of the base slab, we installed feet just over a meter high, on which we lifted a round concrete slab. The tower was attached to it, says work manager Kalevi Savolainen.

Valves and piping were installed in the space under the tower. The insulation of the lower part was also supplemented. The finished tower was raised with a truck crane. - The work went as planned. Already during the installation work, guests visited the site. The insulated aeration tank is interesting because there is little space for such massive structures in a few places, Savolainen says. The contractor completed the tower by installing exterior cladding.
