Renovation of damaged stoneware collector – cracking/short relining

Renovation of damaged stoneware collector – cracking/short relining with the use of VipLiner modules

Tomaszów Mazowiecki, Poland

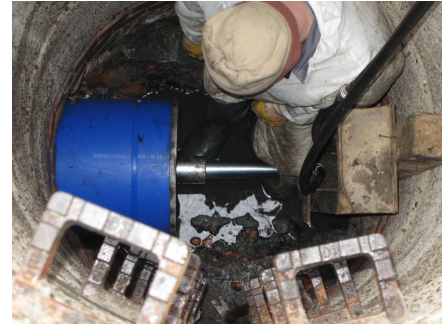
Renovation of damaged stoneware collector – cracking/short relining with the use of VipLiner modules

Upon analysing various renovation technologies it was resolved to repair the collector with the use of VipLiner polyethylene modules PE100 RC with increased resistance to propagation of cracks, point pressure and result of scratching, Blejkan, the contractor of the project, applied the static cracking method, which concerned the crushing of the old collector with the use of the head connected by steel bolted poles with the hydraulic drive hoist and parallel insertion of VipLiner modules after the head. This method allowed to improve the hydraulic parameters of the sewage network. Uponor Infra delivered for this investment VipLiner modules of 0.5 m length and diameter respectively higher than the renovated section (dn355 and 450mm).
