## Plastic pipe withstands mill's process water

## Projekta fakti:

Location	Pabeigts
Imatra, Finland	2013

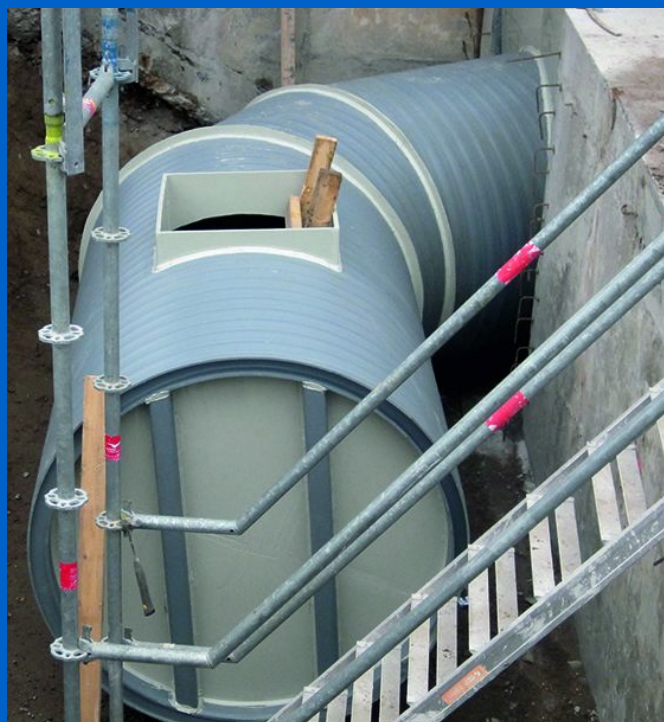
The process water required in the manufacture of board and paper has thus far run through concrete channels to the treatment process facility, after which the water has been discharged into Lake Saimaa. The hot water that contains chemicals has worn down and eroded the concrete structures so much that a new solution had to be found for transporting the process water.

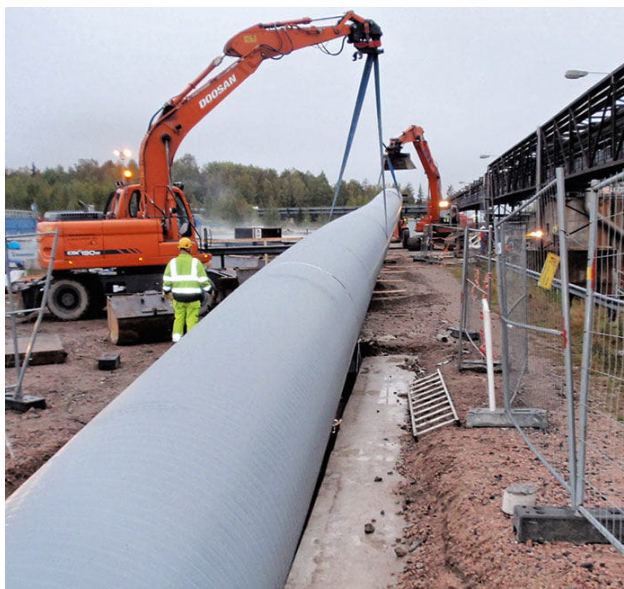
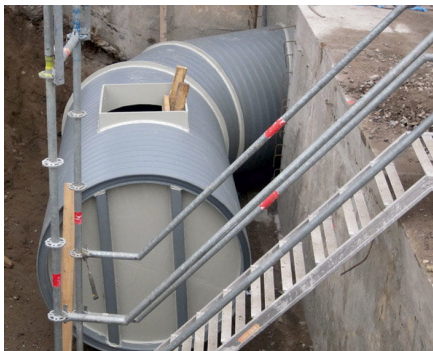
During the first stage, seventy metres of pipe, with a diameter of 1.6 metres, was installed at the mill. The pipe was slid into the existing concrete channel. Additionally, two segment bends were installed in preparation for the project's second stage. At that time, a further 120 metres of pipe will be added to the system and buried underground. As the pipeline will curve back and forth, completion of the installation work will require the addition of five or six segment bends. Dite manager Kimmo Sjöman oversaw the preparation and installation work during the first stage of the project at Imatra.

According to Mr Sjöman, sliding the stiff pipe into a square tunnel was somewhat difficult, as there was little space and the pipe did not bend easily. The outside diameter of the pipe was 1.8 metres. The pipe was slid into a square tunnel that was 2 x 2 metres in size.
