Getting rid of indoor radon

Uponor's radon system was installed in a detached house in Ilomantsi, completed in 1987. Previously, the radon values in the house were 1,188 becquerels. After installing the system, the radon values dropped to 83.

Location	Conclusão
Ilomantsi, Finland	2014
Tipo de edifício	Product systems
Residencia unifamiliar	Ventilação
Tipo de projeto	
Novo edifício

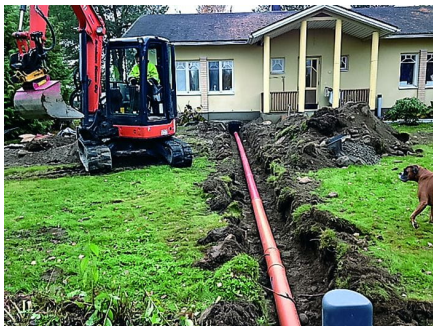
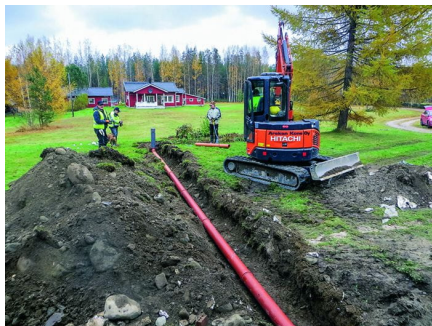
Eroon sisailman radonista

The installation contract went quickly and easily in one working day. The work began with the excavation of a well of about three and a half meters. At the bottom of the well came crushed stone and a vacuum cleaner, from which came about a 15-meter drainage pipe.

An exhaust air fan built into the system creates a vacuum under the house, which absorbs radon gas into the suction duct and moves it out of the vicinity of the house in a controlled and safe manner along the exhaust duct.

- We are satisfied with the radon repair and the work of the contractors. The radon concentration in the downstairs room was as high as 1,188 becquerels before the radon renovation, but dropped to 83 after the radon system was installed. A similar decline was also seen upstairs, where radon values fell from 621 becquerels to 20, Savola says.
