lisalmen Vesi renovated a trunk line by relining

- ✔ 2.1 kilometres of 280-millimetre Profuse pipe

Location	Conclusão
lissalmi, Finland	2017
Tipo de edifício	Product systems
Edifício público	Potable water
Tipo de projeto	
Renovation

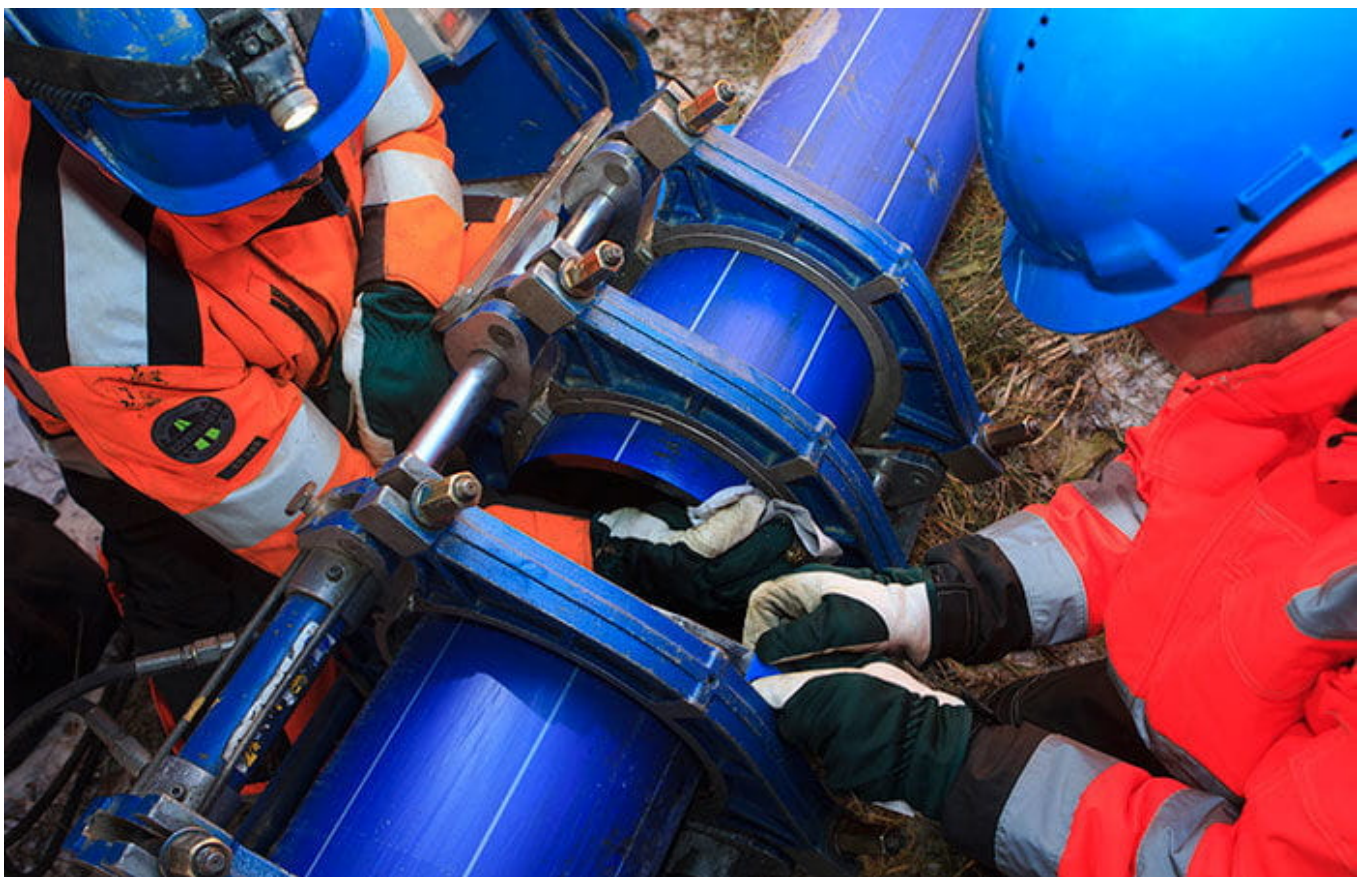
Iisalmen Vesi renovated a trunk line by relining
