Referencie

## Renovation of the sewage collector

## Renovation of the sewage collector in Swarzewo

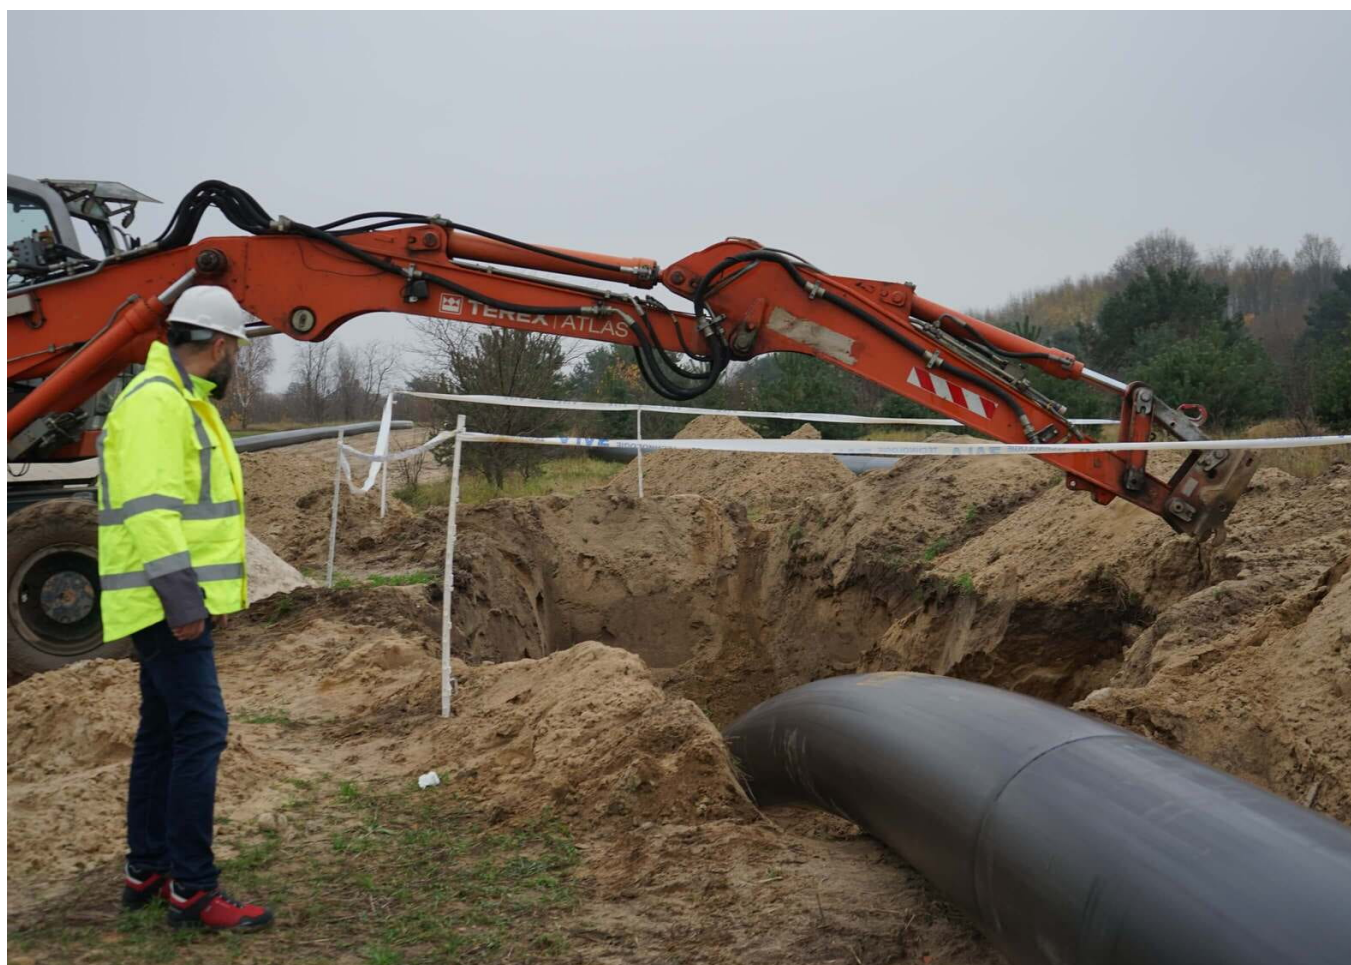
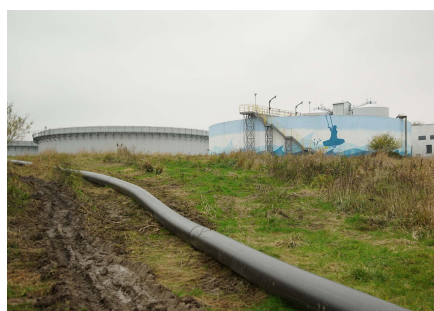
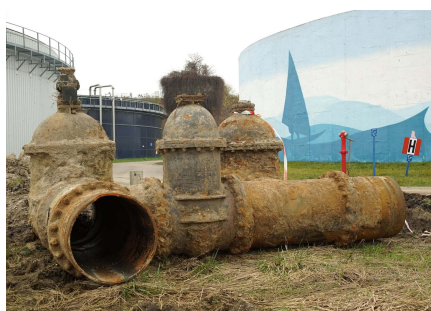
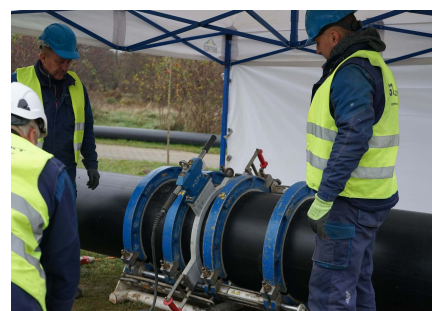
Deliveries of pipes for the described investment started in September 2021. For the renovation of the Władysławowo-Swarzewo collector pipe, it was decided to use WehoPipe PE100 DN600x23.0 PN6.3 SDR26 pressure pipes with a total length of 2,530 m. They were transported to the worksite in 12.5 m sections. The pipes were joined together by butt welding. A DN630 welding machine was used for this purpose. Deliveries were completed in February 2022.

The installation technology consists of pulling long sections of PEHD pressure pipe into the old pipe, with the outer diameter of the pipe to be introduced originally being equal to or slightly larger than the inner diameter of the pipe to be repaired. Then, after welding, the pipe is pulled through the reducer so that the outside diameter is reduced and it can be inserted into the pipeline to be repaired. The pulling force is then released and the PEHD pipe, after a relaxation process, presses tightly against the inner wall of the old pipeline. The advantage of this technology is that a small reduction in the inside diameter of the repaired duct is achieved, which, with a significant reduction in surface roughness, significantly improves throughput. There is also no need to fill in the space between the old and new pipe, the renewed pipe does not require further repairs and maintenance. An additional benefit is the structural reinforcement of the repaired sewer - the new pipeline is self-supporting, carrying the load.
