Water treatment plant

Aeration tank to improve the water quality

Water company Ylä-Savon Vesi Oy needed a solution to improve the water quality in water supply process. The solution was an aeration tank made of Weholite.

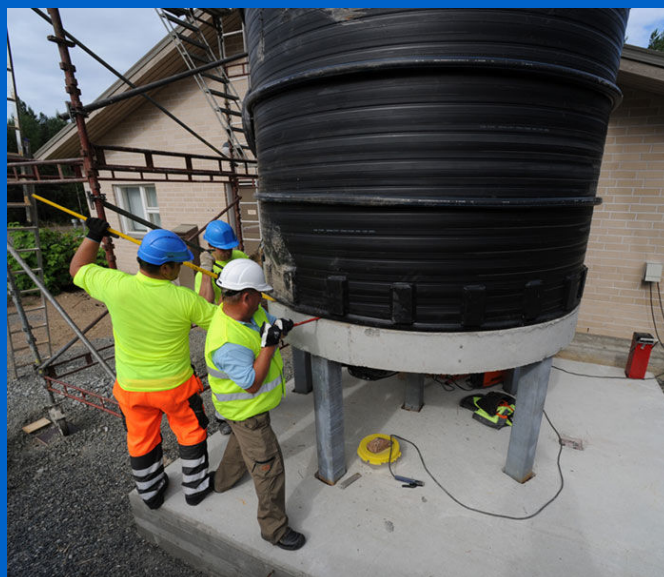
- ✓ 2.4 m diameter Weholite tank

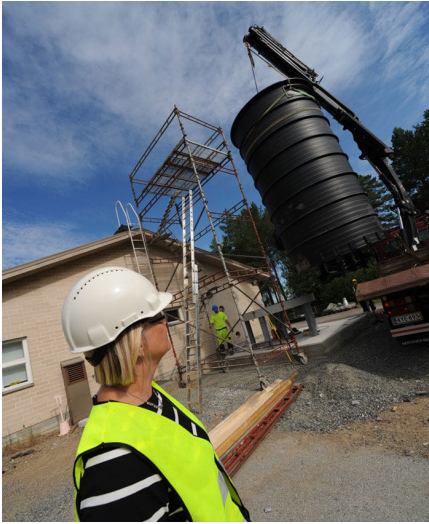
Weholite aeration tank

In aeration that improves water quality, water is led to the tower from above. The water flows through the infill mattress in the tower, removing the carbon dioxide in the raw water. Aeration can be adjusted by blowing clean air under the tower through the mattress upstream.

The amount of air does not require the tower to withstand greater pressure than normal in normal use, but the Weholite tank can also withstand the full water pressure of the tank, for example in the event of washing or disturbances.

- The concrete slab under the tower had already been made in advance. On top of the base slab, we installed feet just over a meter high, on which we lifted a round concrete slab. The tower was attached to it, says work manager Kalevi Savolainen.

Valves and piping were installed in the space under the tower. The insulation of the lower part was also supplemented. The finished tower was raised with a truck crane. - The work went as planned. Already during the installation work, guests visited the site. The insulated aeration tank is interesting because there is little space for such massive structures in a few places, Savolainen says. The contractor completed the tower by installing exterior cladding.
