lisalmen Vesi renovated a trunk line by relining

- ✔ 2.1 kilometres of 280-millimetre Profuse pipe

Projektfakta

Location	Färdigställt
lissalmi, Finland	2017
Byggnadstyp	Product systems
Kommunal mark	Tryckrörssystem

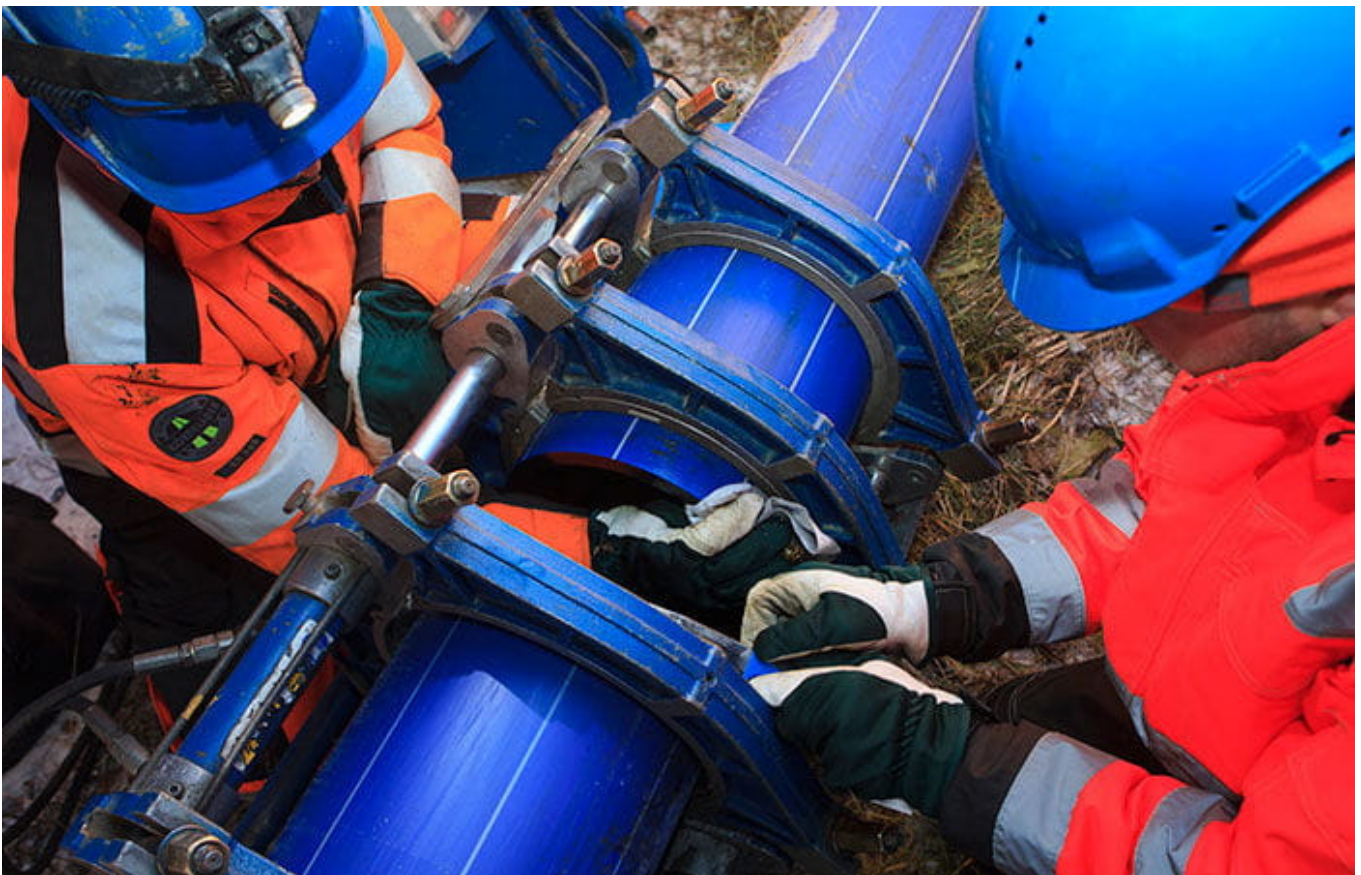
Iisalmen Vesi renovated a trunk line by relining

The 280-millimetre Profuse pipe was fitted smoothly into the 300-millimetre asbestos-concrete pipe. Therefore, there was no need to compromise on performance.

The relining job was split into 150–200 m portions based on the line's valves and branches. Paltamo-based Pyykkönen Yhtiöt Oy dug a total of 14 excavations at both ends of the relinings, and the new pipe was winched inside the old one by a lorry. Uponor Infra's fitters built the lines from 12-metre pipes by percussion welding.
