Fighting against an ecological disaster in a world-record time

Rapid action was critical when a sewage collector broke in Warsaw, Poland, causing a massive waste spill into the Vistula River. Uponor Infra's crew worked 24 hours a day in order to stop the pollution of the river. A temporary pipeline was produced, delivered and connected in just eight days.

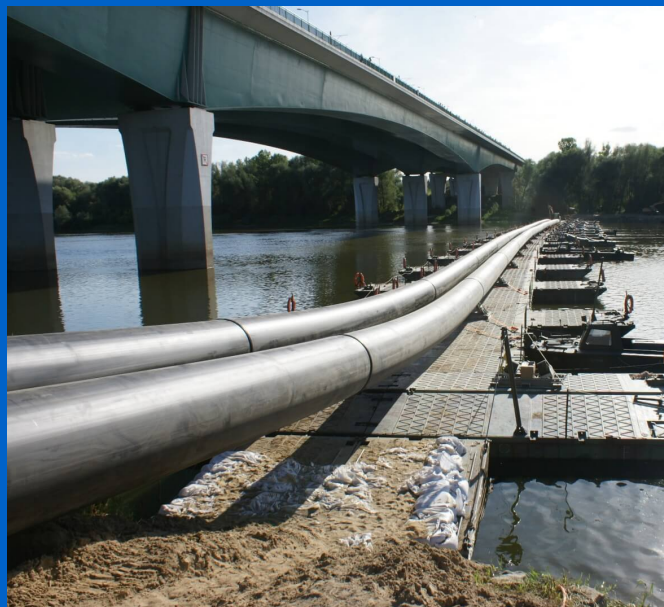
Uponors roll

- ✓ PEHD pipes DN1000 PN10 SDR17 – 1242 m, PN16 SDR17 – 958 m
