Water treatment plant

Aeration tank to improve the water quality

Water company Ylä-Savon Vesi Oy needed a solution to improve the water quality in water supply process. The solution was an aeration tank made of Weholite.

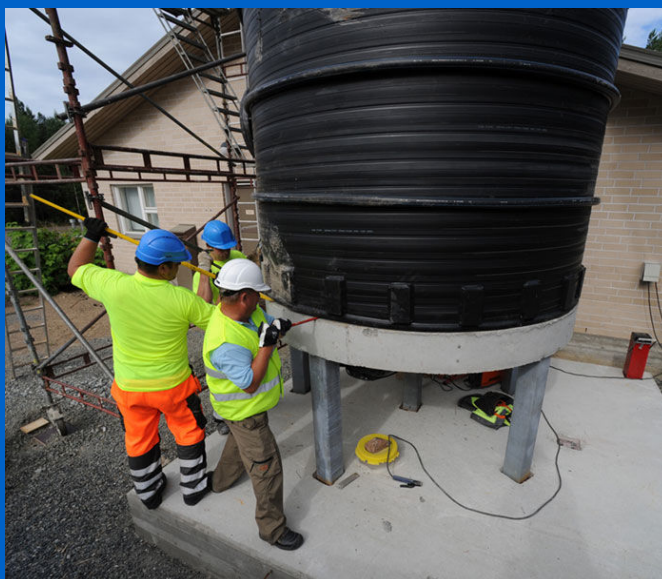
- ✓ 2.4 m diameter Weholite tank

- We also had the idea that aeration towers would complement the products of the water supply system well. The contact of Ylä-Savo water thus came in a good seam. Our technical advice had time to think of a solution in peace. The cooperation went very well from start to finish. The aeration tower was built at the Vaasa plant from a 2.4-meter Weholite pipe.
