Renovation of damaged stoneware collector – cracking/short relining

Renovation of damaged stoneware collector – cracking/short relining with the use of VipLiner modules

Location	Рік завершення будівництва
Tomaszów Mazowiecki, Poland	2014
Тип будівлі	Системи продуктів
Комунальні об'єкти	Реконструкція, Муніципальні каналізаційні мережі

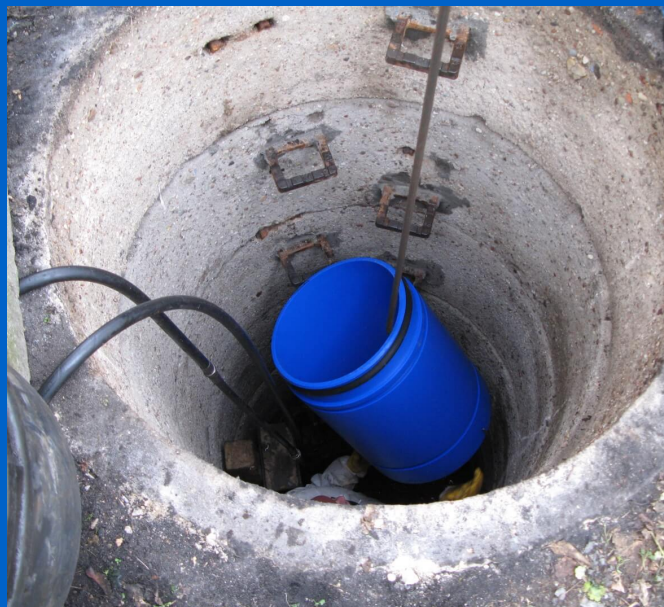
In Tomaszów Mazowiecki renovation of a damaged stoneware collector was carried out by means of static cracking method using VipLiner polyethylene modules

Upon analysing various renovation technologies it was resolved to repair the collector with the use of VipLiner polyethylene modules PE100 RC with increased resistance to propagation of cracks, point pressure and result of scratching, Blejkan, the contractor of the project, applied the static cracking method, which concerned the crushing of the old collector with the use of the head connected by steel bolted poles with the hydraulic drive hoist and parallel insertion of VipLiner modules after the head. This method allowed to improve the hydraulic parameters of the sewage network. Uponor Infra delivered for this investment VipLiner modules of 0.5 m length and diameter respectively higher than the renovated section (dn355 and 450mm).

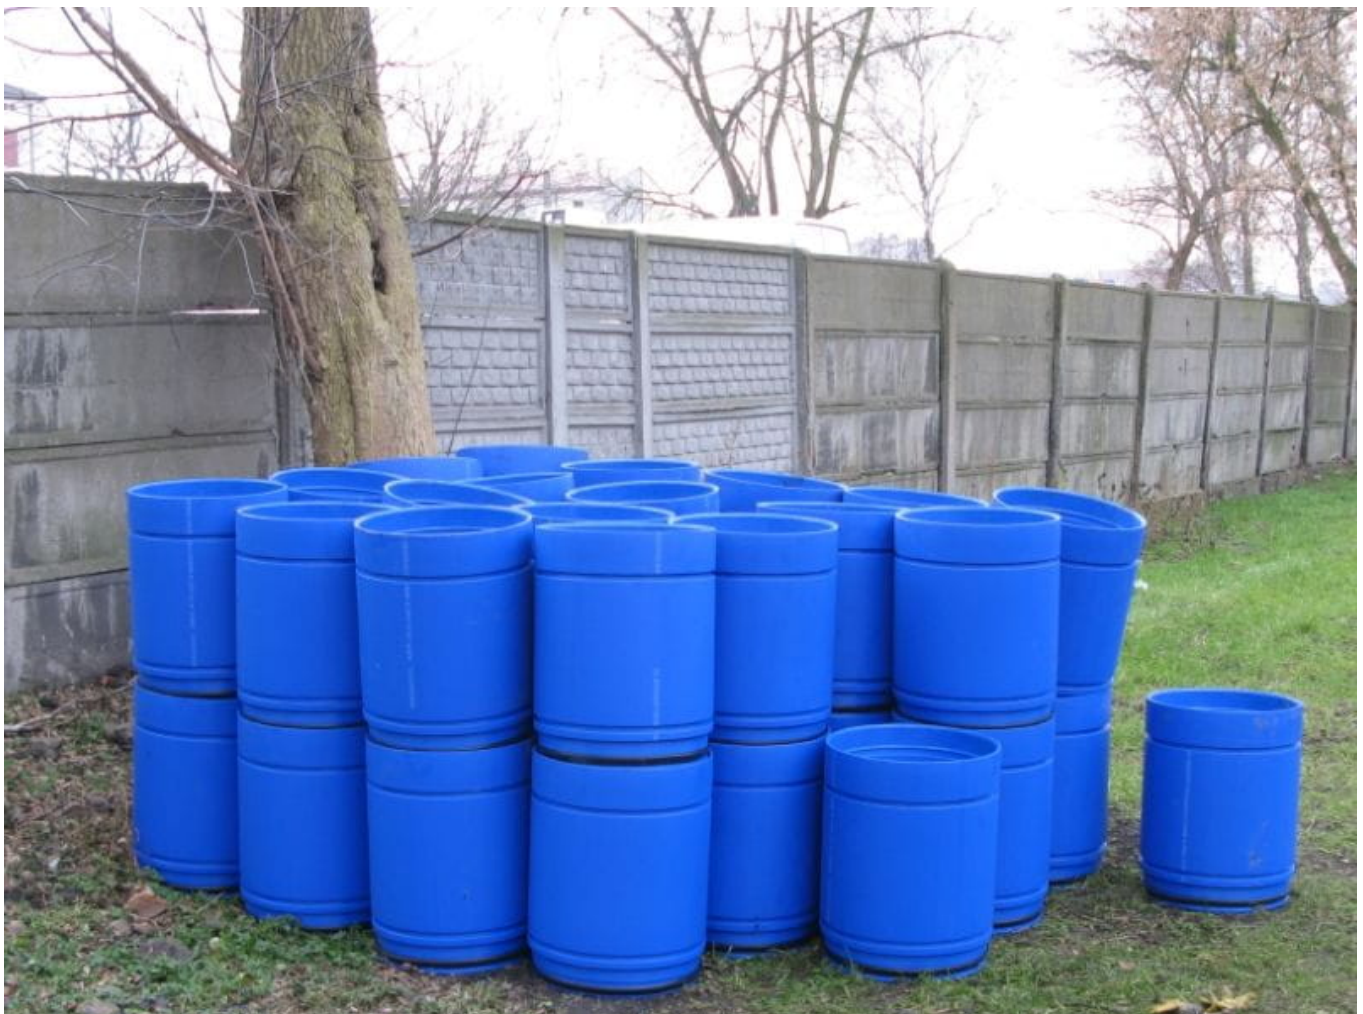
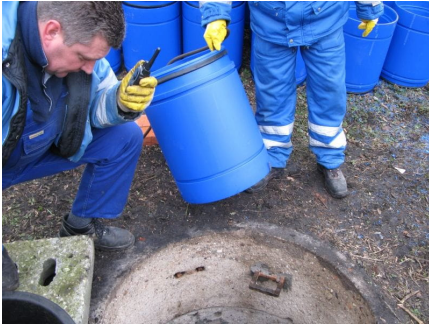
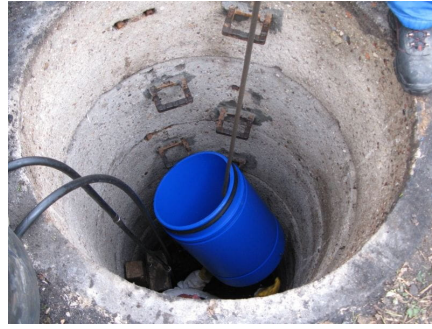
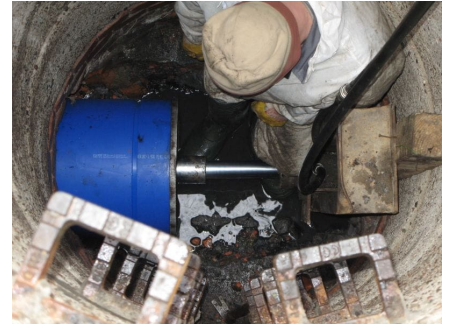
Renovation of damaged stoneware collector – cracking/short relining with the use of VipLiner modules

In Tomaszów Mazowiecki renovation of a damaged stoneware collector was carried out by means of static cracking method using VipLiner polyethylene modules. In 2013 a decision was made to carry out renovation of the stoneware collector of diameter dn250mm and dn400mm. The collector was leaking in numerous places, particularly in the places of its connection with the manholes.

The works were carried out in winter at the turn of 2013/2014. The renovation included 8 sections and the longest section between the manholes was 60 m. The contractor commended the easy and simple nature of installation of the modules and the speed of works using VipLiner modules (the average renovation time of a section was approx. 3 days).
