Water treatment plant

Aeration tank to improve the water quality

Water company Ylä-Savon Vesi Oy needed a solution to improve the water quality in water supply process. The solution was an aeration tank made of Weholite.

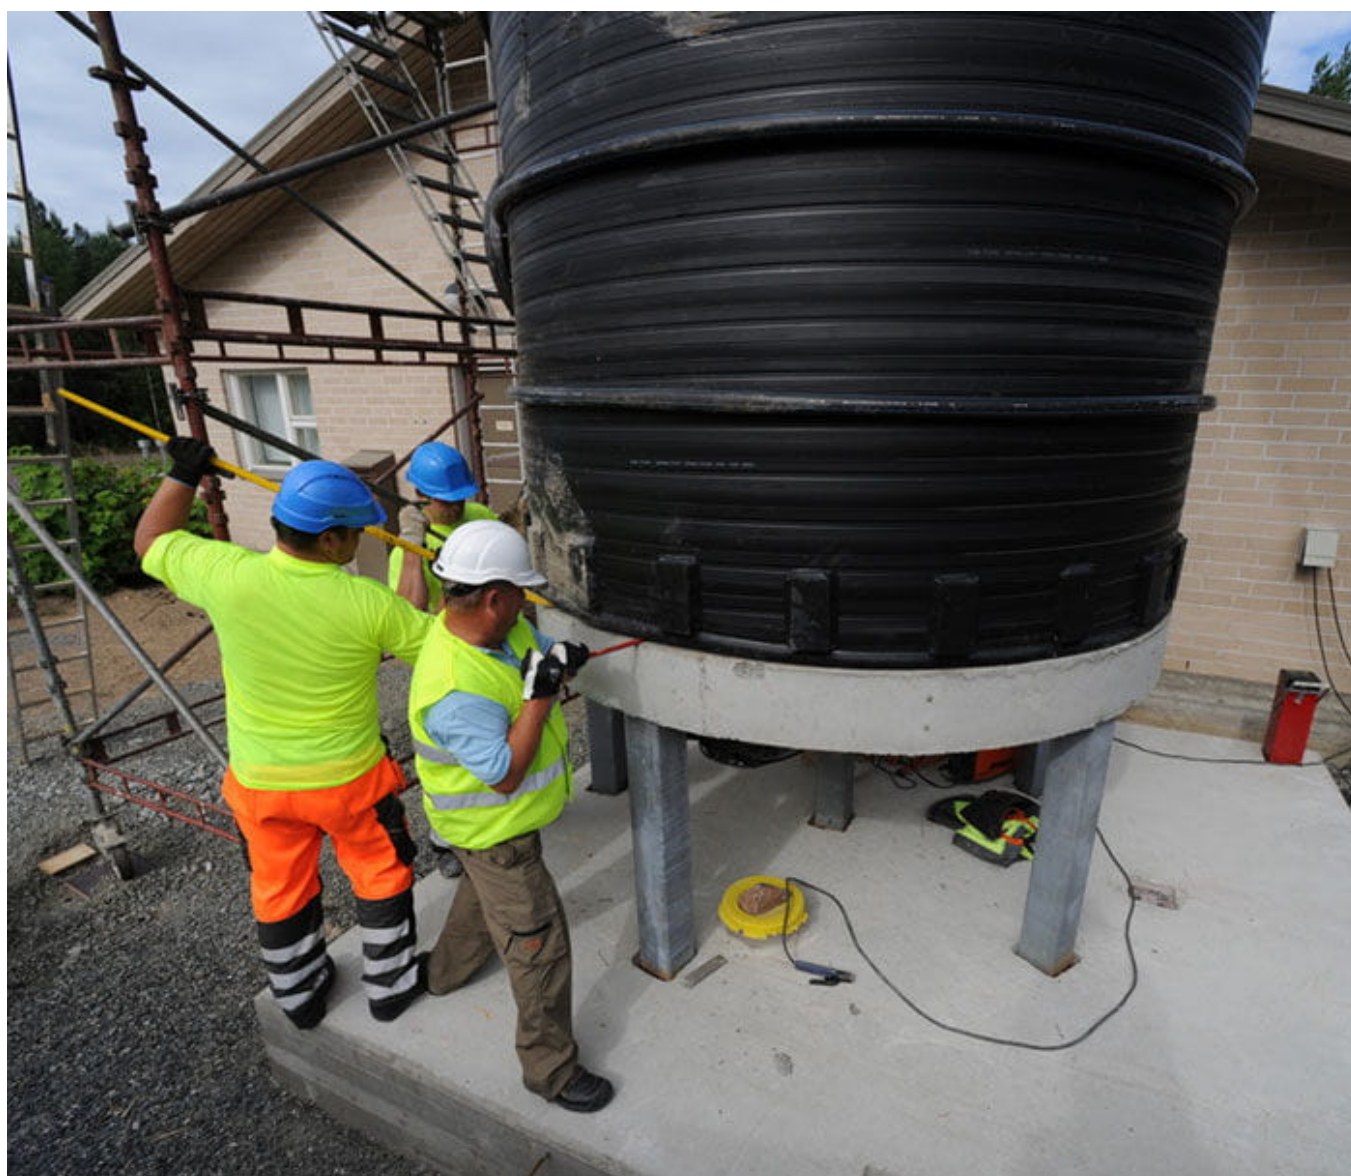
Weholite aeration tank

In aeration that improves water quality, water is led to the tower from above. The water flows through the infill mattress in the tower, removing the carbon dioxide in the raw water. Aeration can be adjusted by blowing clean air under the tower through the mattress upstream.

The amount of air does not require the tower to withstand greater pressure than normal in normal use, but the Weholite tank can also withstand the full water pressure of the tank, for example in the event of washing or disturbances.

- As the tank could not be installed indoors, hygiene had to be taken into account in its design: no free openings could be left. The service hatches must be tight, as outdoor air pollutants must not get into the domestic water, Pekka Iivari reminds.

- The thermal insulation of the tower was done at the factory, and there was no need to work with the villas on the construction site, Heiskanen says. The aeration tower was completed at the Vaasa plant. Savo-Karjalan Vesihuolto Oy installed the aeration tower in the summer of 2010.

- The concrete slab under the tower had already been made in advance. On top of the base slab, we installed feet just over a meter high, on which we lifted a round concrete slab. The tower was attached to it, says work manager Kalevi Savolainen.

Valves and piping were installed in the space under the tower. The insulation of the lower part was also supplemented. The finished tower was raised with a truck crane. - The work went as planned. Already during the installation work, guests visited the site. The insulated aeration tank is interesting because there is little space for such massive structures in a few places, Savolainen says. The contractor completed the tower by installing exterior cladding.
