lisalmen Vesi renovated a trunk line by relining

Project Facts:

Location	Completion
lissalmi, Finland	2017
Building Type	Product systems
☒☒☒☒	Potable water
Project Type	
Renovation

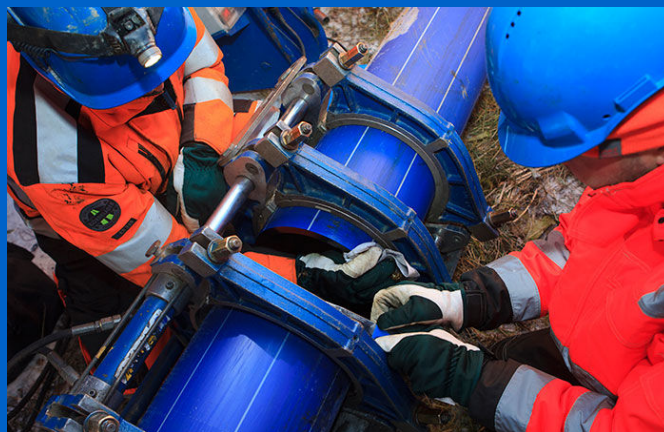
- ✔ 2.1 kilometres of 280-millimetre Profuse pipe

The 280-millimetre Profuse pipe was fitted smoothly into the 300-millimetre asbestos-concrete pipe. Therefore, there was no need to compromise on performance.

The relining job was split into 150–200 m portions based on the line's valves and branches. Paltamo-based Pyykkönen Yhtiöt Oy dug a total of 14 excavations at both ends of the relinings, and the new pipe was winched inside the old one by a lorry. Uponor Infra's fitters built the lines from 12-metre pipes by percussion welding.
