Quick installation in the Konotopa channel

- ✔ Weholite pipes PEHD SN4 DN2000 mm – 165 m

Weholite guaranteed a simple and quick installation in the Konotopa channel

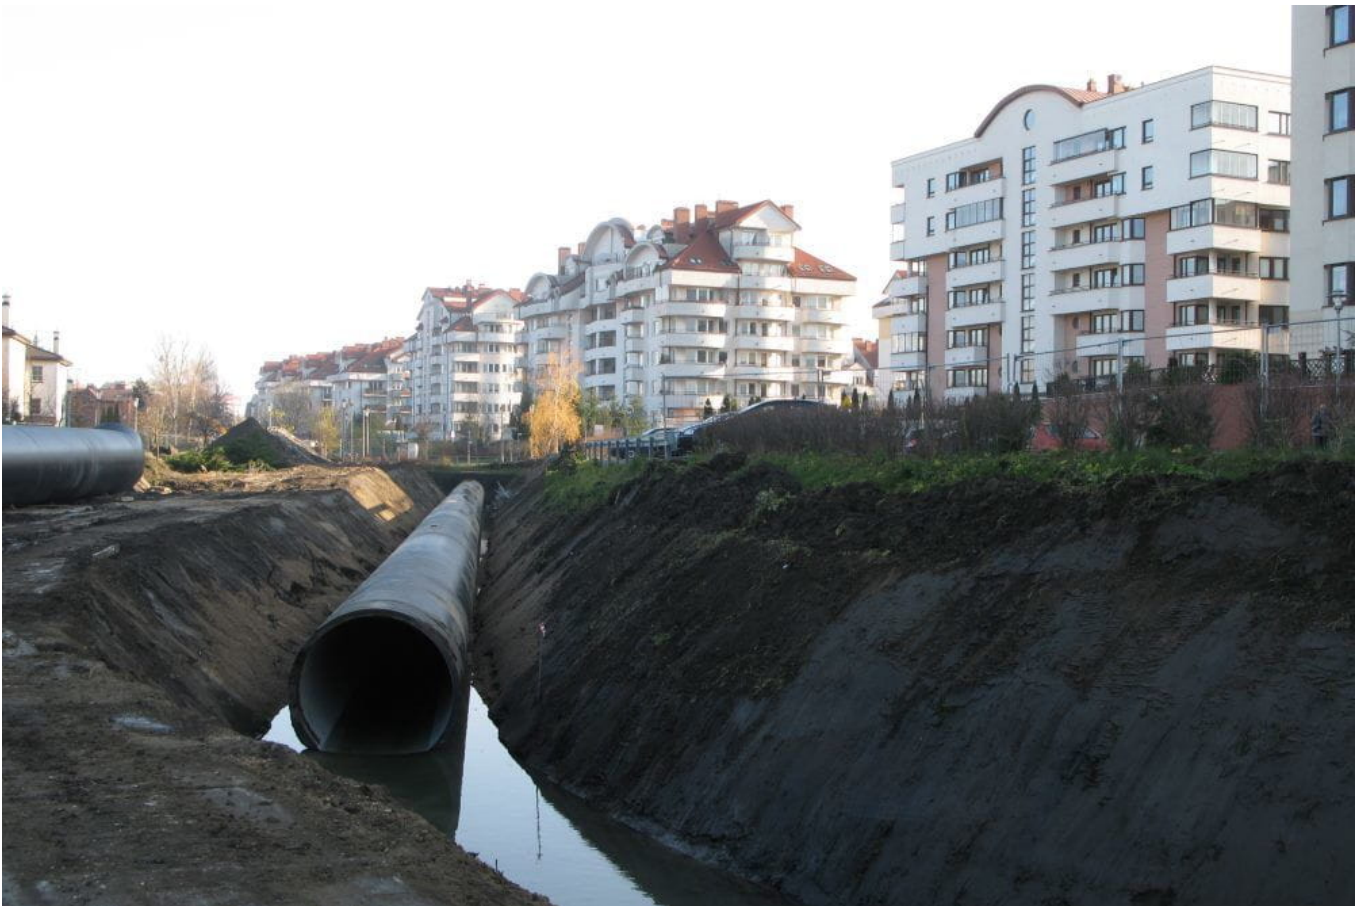
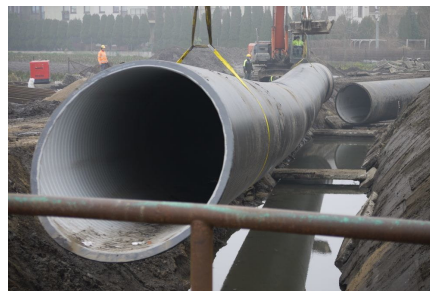
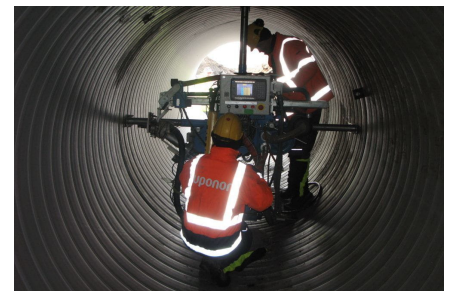
Following a tender, in September 2016 Drainage Construction Company Tolos was appointed as the general contractor for the project. Uponor Infra delivered a total of 165 metres of structured-wall PE-HD Weholite, DN/ID 2,000mm SN4 pipes to the installation site. Prep work included clearing the channel of concrete slab lining, dredging the ditch to make room for the new pipeline and laying the bedding. Uponor Infra pipe service staff then joined up the Weholite pipes to form two sections. The work was carried out on dry land on the right bank of the channel, by means of automatic extrusion welding using a WLI- 3000 machine. This guaranteed the 100% tightness and homogeneity of the pipeline. A 100- metre section of pipeline was then lowered into the ditch, followed by the remaining 50-metre section with a fitted bend two days later. Since the channel was operational during installation, the two connecting sections of the pipeline were raised above the water level, where they were welded together. The pipeline was then connected to a reinforced concrete inlet of the underground section of the channel. A socket- and- spigot DN/ID200mm joint was fitted onto the pipeline, connecting it to an existing stormwater channel. Finally, the ditch was backfilled. At the spot where the new pipeline meets the open section of the channel, an outlet was secured with a steel grate to prevent unauthorised entry. The installation was completed in December 2016.

Weholite guaranteed a simple and quick installation in the Konotopa channel
